Mangrove Restoration

A DOI Nature-Based Solutions Roadmap Fact Sheet

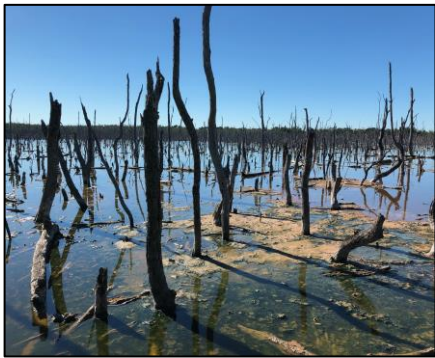
Dead mangrove trees and stagnant water at the Fruit Farm Creek site prior to restoration. Photo credit: Sara Mason.

The Fruit Farm Creek mangrove restoration at the Rookery Bay National Estuarine Research Reserve took over 13 years from planning to implementation. The 200 acre mangrove site had collapsed due to hydrological changes that prevented natural tidal flows from reaching the habitat. Restoration actions centered on installing culverts and clearing tidal creeks to allow a more natural hydrologic regime. Revegetation occurred through natural regeneration.
