RESTORATION

Restoration of Riparian Trees and Shrubs on the Rio Grande Canalization Project

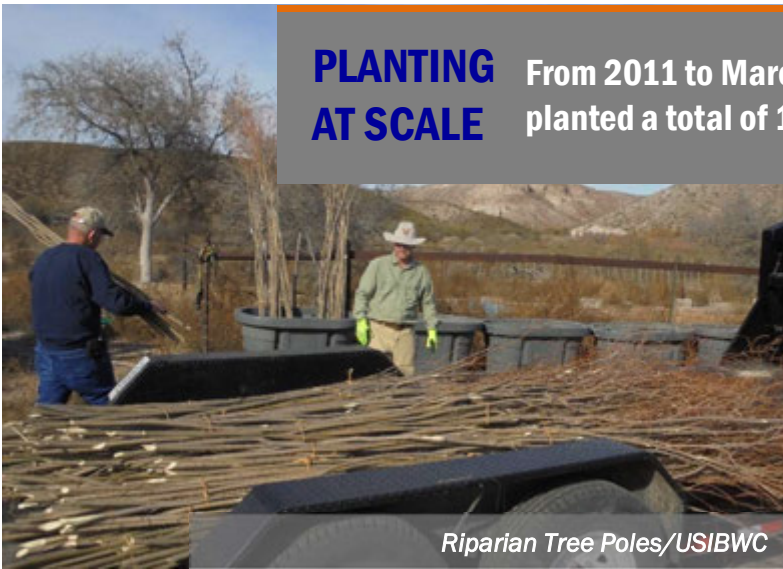
Riparian Tree Poles/USIBWC

Depth to Groundwater: Using well monitoring data, USIBWC determined that native riparian tree poles need to be planted to a depth of at least 10 feet to survive groundwater fluctuations.

Planting Methods: Planting methods varied by restoration team and site conditions. They included augering holes for poles, excavating trenches for planting poles, and transplanting willows with root balls and topsoil intact into trenches dug down to groundwater level (8-10 feet).

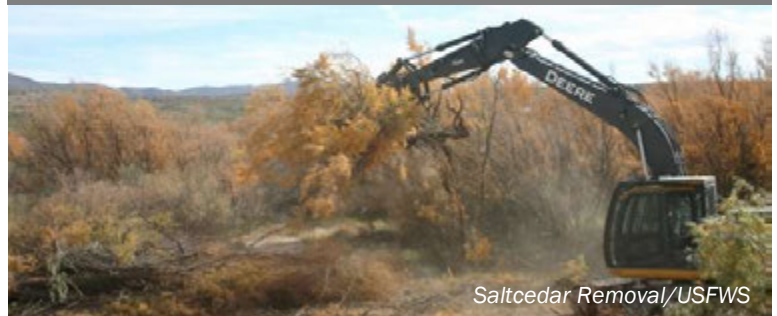
Saltcedar Removal/USFWS

Site Preparation: Prior to planting, teams removed saltcedar using mechanical and chemical methods. At some sites, USIBWC and partners excavated swales in the floodplain to improve drainage and groundwater conditions near plantings.
