Floodplain Restoration for Salmonid Habitat in the
Yakima Basin

A Case Study on Restoration

April 20, 2023

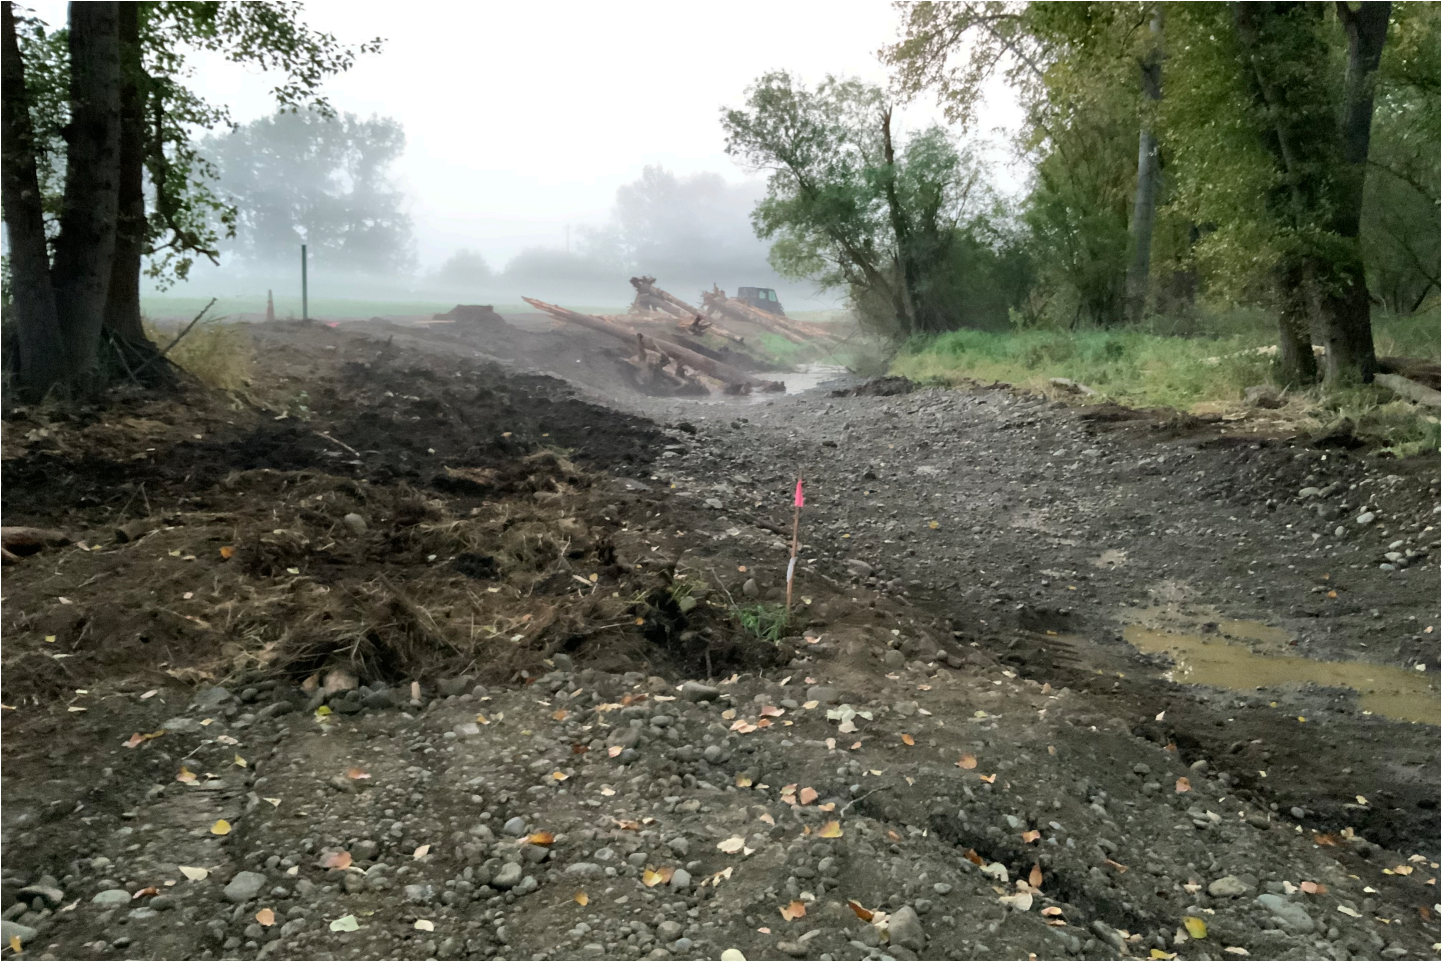
Image Caption: *River side channel before construction. Courtesy of Tim DeWeese, Bureau of Reclamation.*

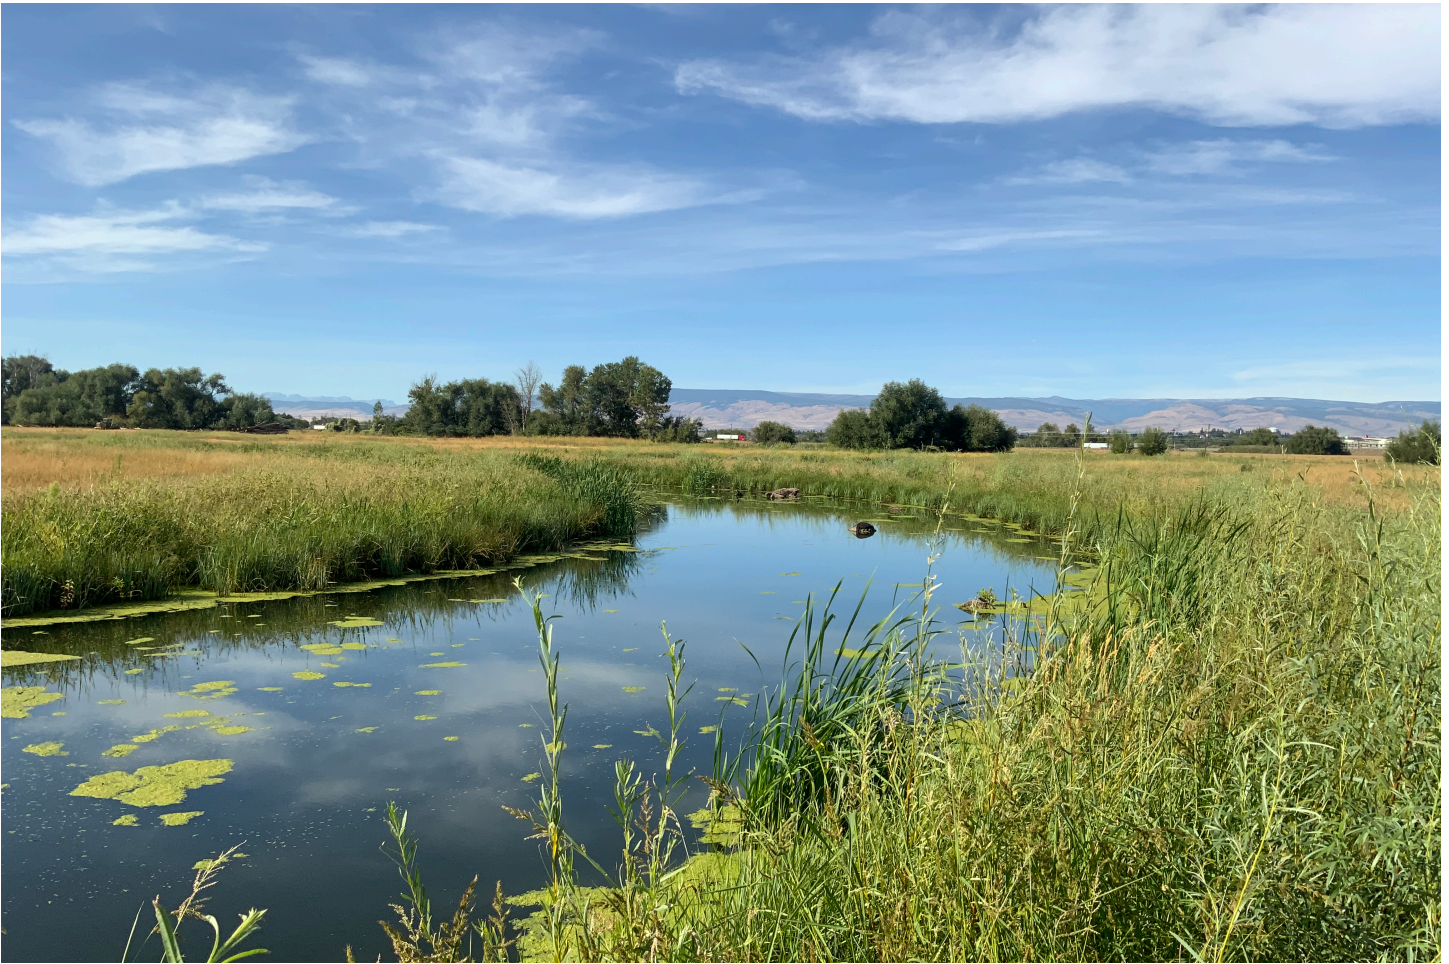
Image Caption: *River side channel during construction. Courtesy of Tim DeWeese, Bureau of Reclamation.*

- **Habitat Creation:** Engineers recontoured the floodplain to create 1.8 miles of perennial side channels that would re-establish hydraulic connectivity and reinvigorate existing side channels. Construction crews excavated existing depressions to increase flow to one mile of existing side channels that were seasonally connected. Juvenile salmonids now have refuge where they can escape heavy water flow.

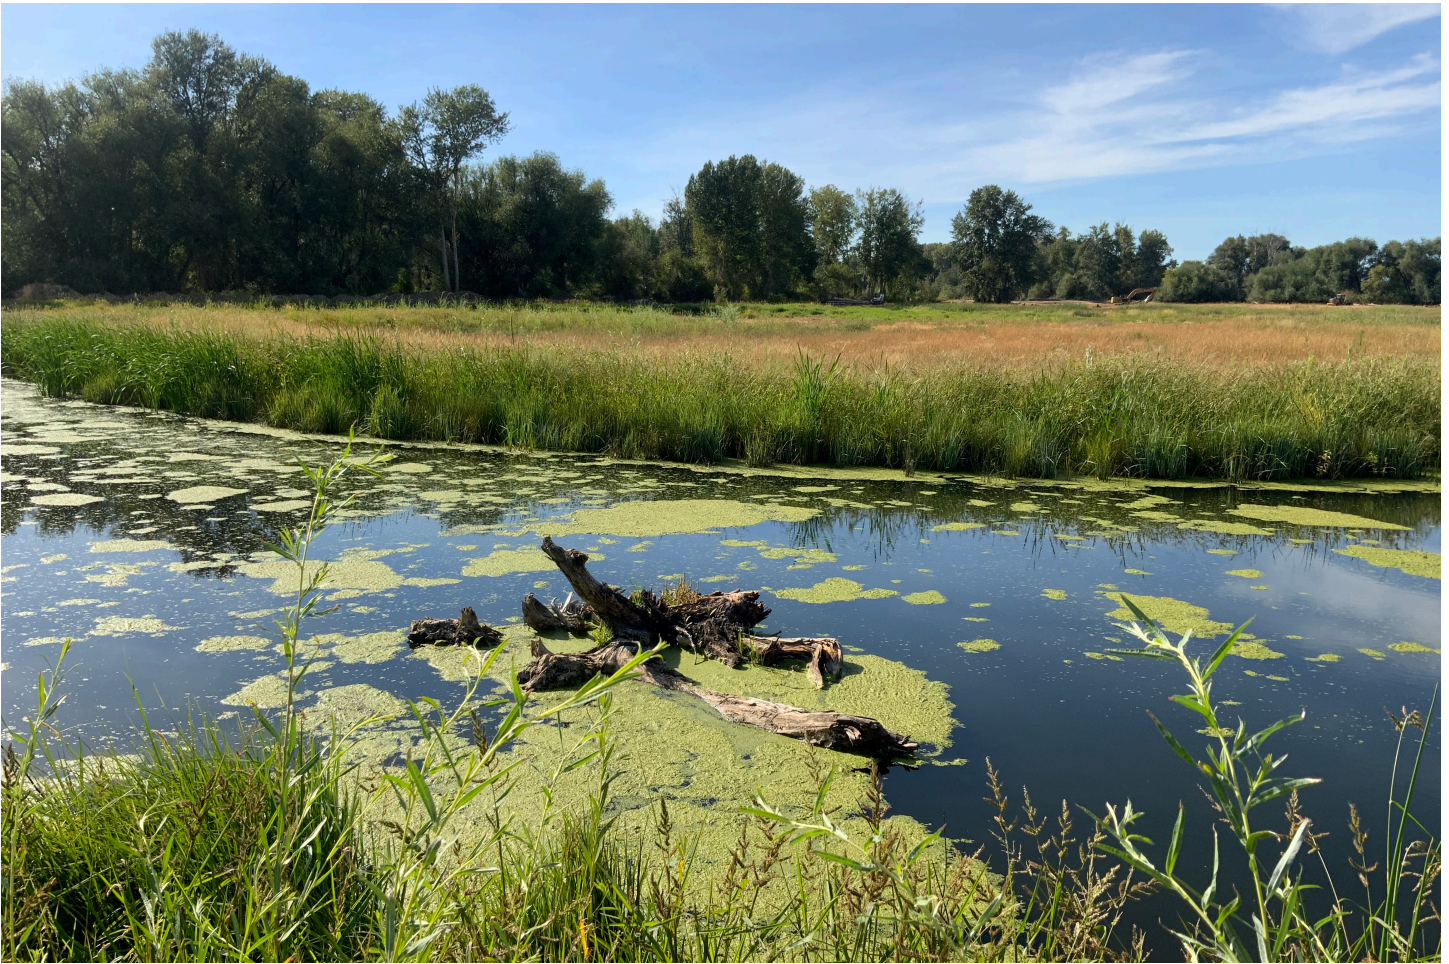
Image Caption: *Results one year after restoration showing extensive waterfowl habitat and growth of wetland sod and willows. Courtesy of Tim DeWeese, Bureau of Reclamation.*

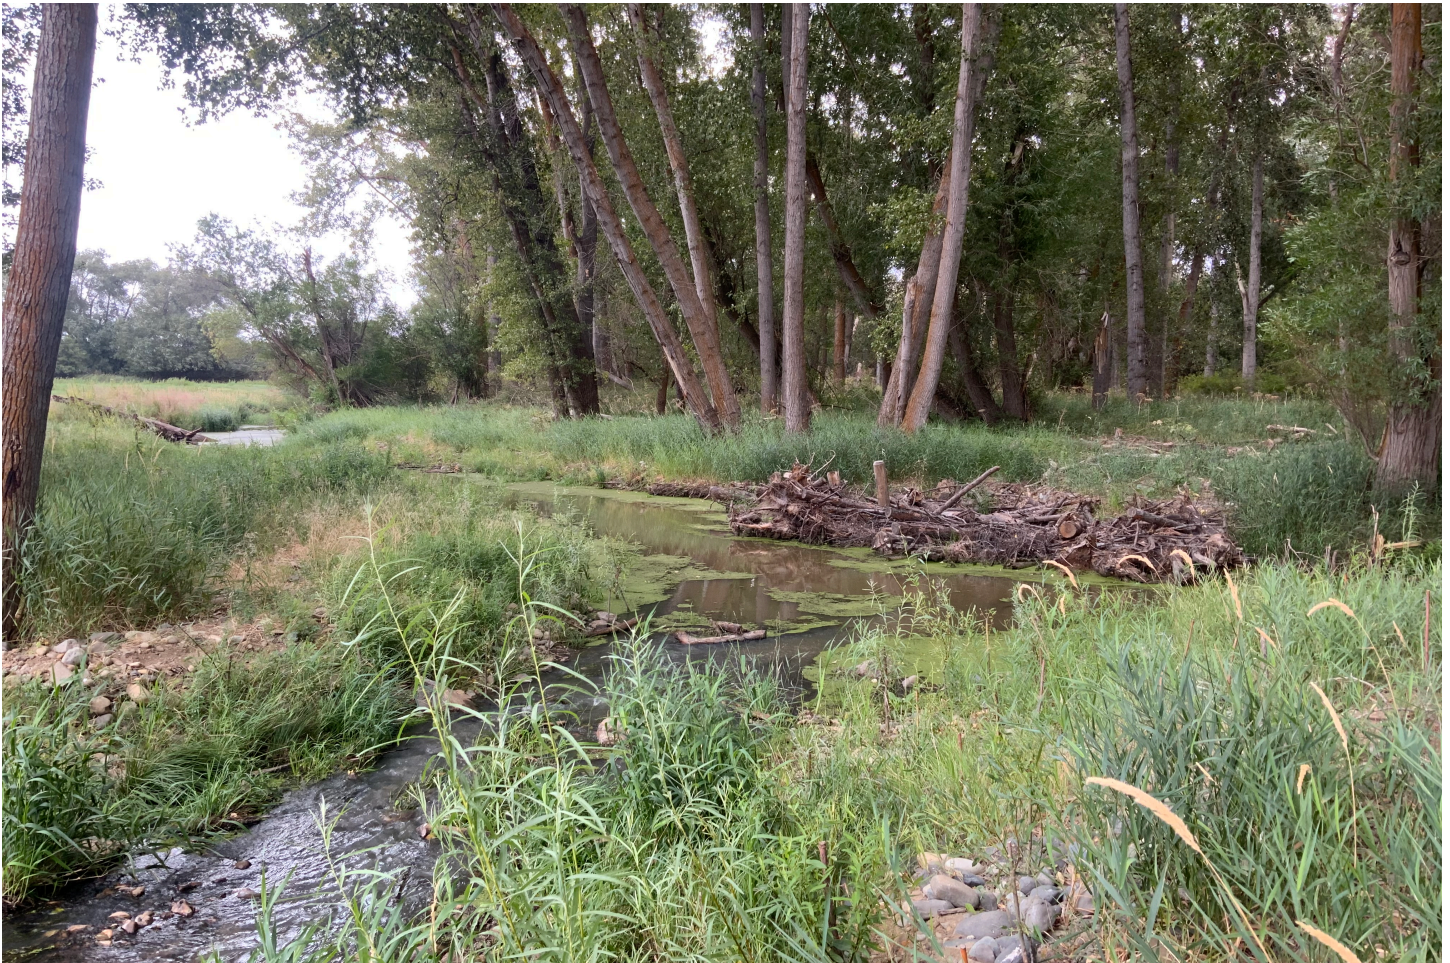
Image Caption: *Results one year after restoration showing extensive waterfowl habitat and growth of wetland sod and*

willows. Courtesy of Tim DeWeese, Bureau of Reclamation.
