Delaware Water Gap

Watergate Wetlands Restoration Project

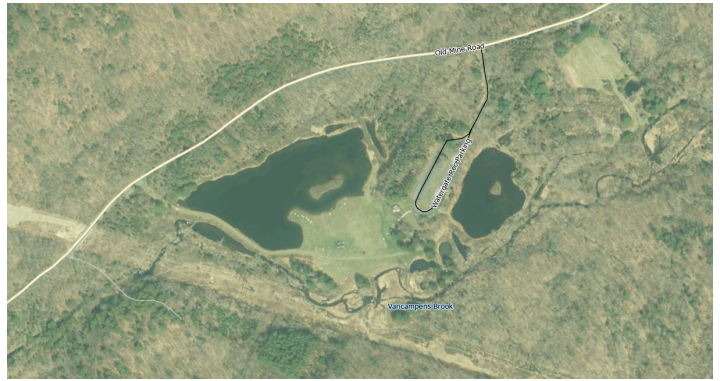
Aerial view of Watergate Recreation Site. Several ponds containing small islands are visible. A straight mowed right-of-way is near the recreation area. Roads and old roadbeds are also highlighted.

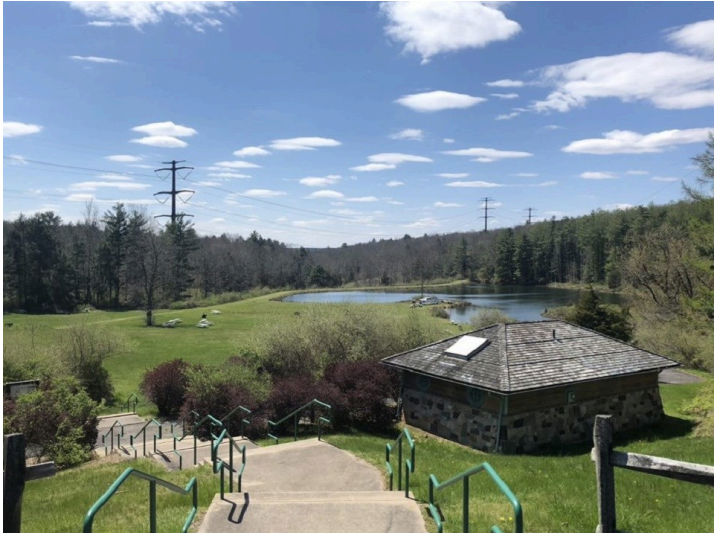
Left image

Before: View from the top of the staircase near the parking lot. A large, manmade pond is in the distance.

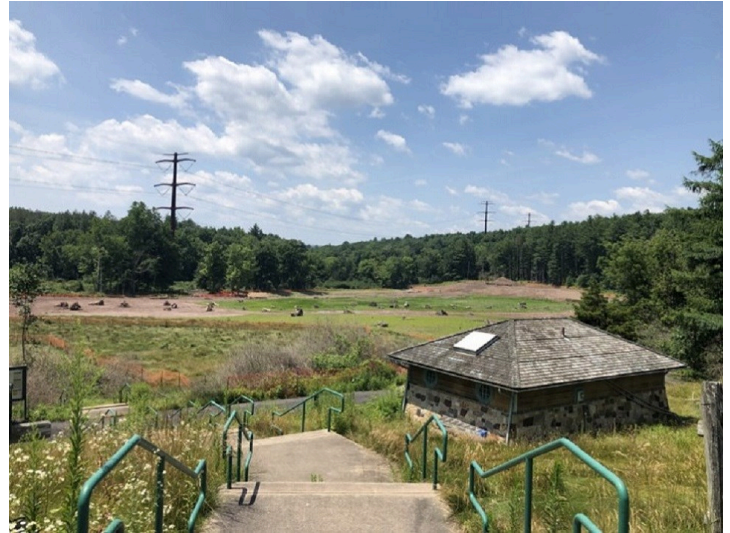
Right image

After: View from the top of the staircase. The pond has been removed and the area leveled. Topsoil was placed and native plant species were planted and have started to grow. Several tree stumps were repurposed into wildlife habitat structures.

Prior to any excavation, numerous trees were taken down in locations that will be returned to wetlands. Some of the trees that were cut down are being reused throughout the project area and along the stream to create habitat structures for small animals. The tree limbs and stumps were stacked and piled in a way to provide shelter, shade, and cover from predators. The tree roots that were placed along the stream also act as protection for the streambank to prevent erosion from future storms.

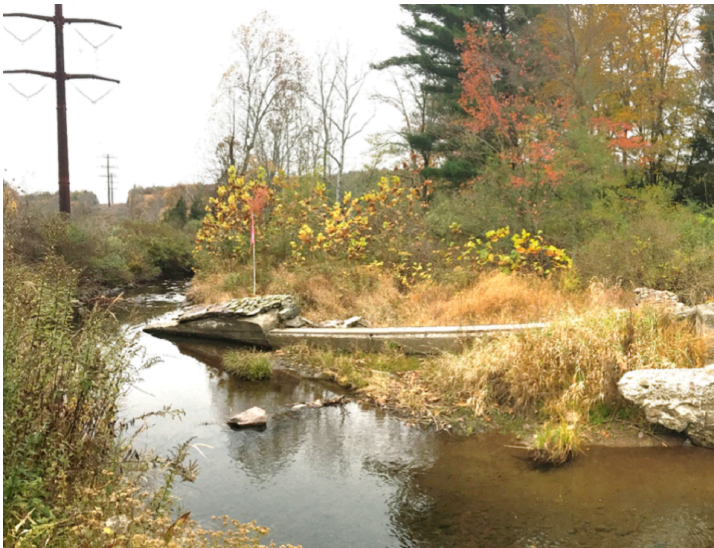
Left image

Before: A failing dam in Van Campens Brook. This dam diverted the stream towards the power lines.

The numerous ponds around Watergate have now been removed, as well as the grassy picnic area. This process involved salvaging fish and pumping the water from the ponds through a sediment-blocking filter and into Van Campens Brook. Once the ponds were drained, the dams could be removed, and the soils could be pushed around to an appropriate elevation and slope to support the groundwater-fed wetlands.

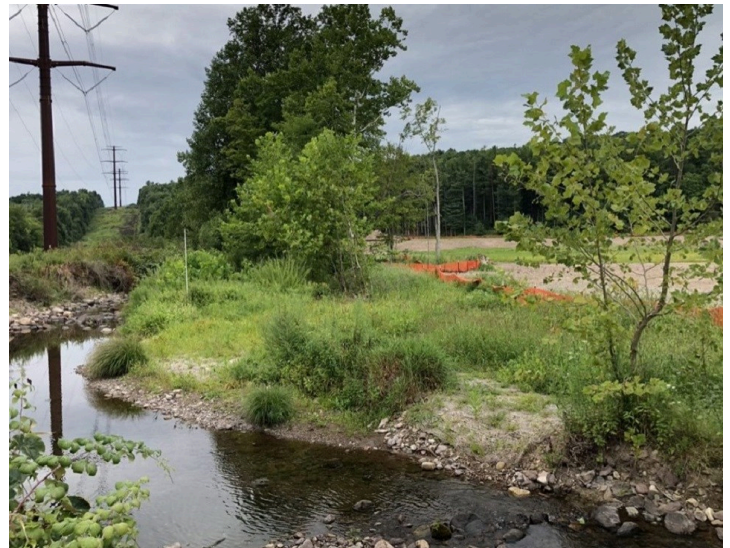
Right image

After: Van Campens Brook after the concrete dam was removed and the streambank restored to its natural state.

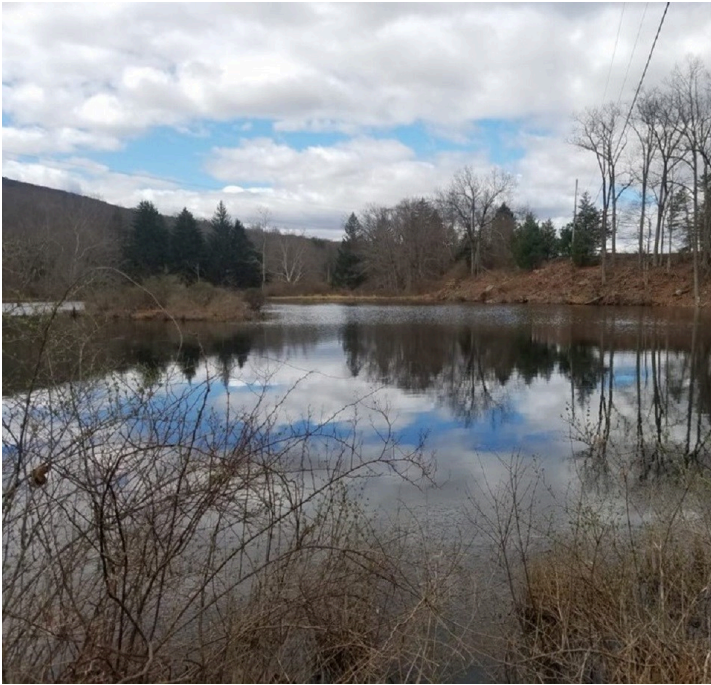
Left image

Before: One of the ponds at Watergate Recreation Site before construction began.

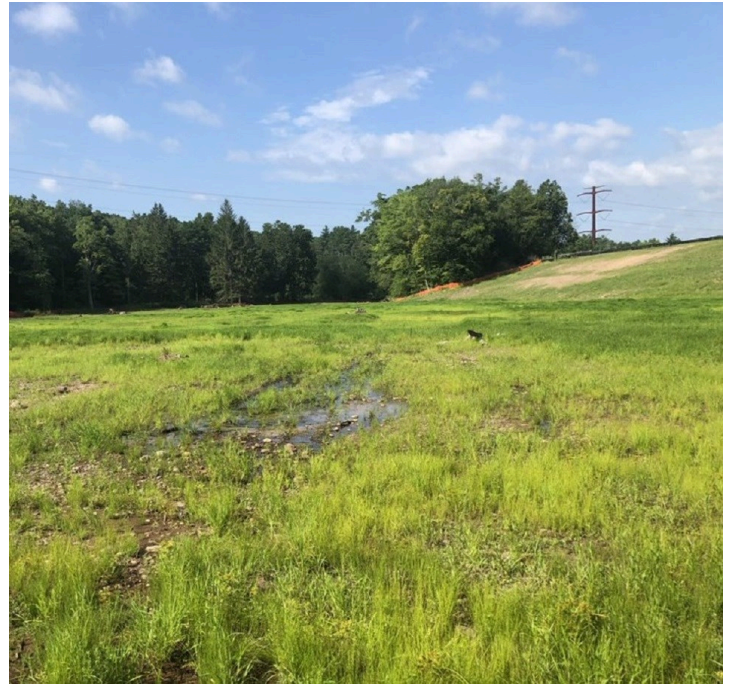
Right image

After: The pond area after it has been dewatered, excavated to the appropriate grade, and planted with native vegetation.

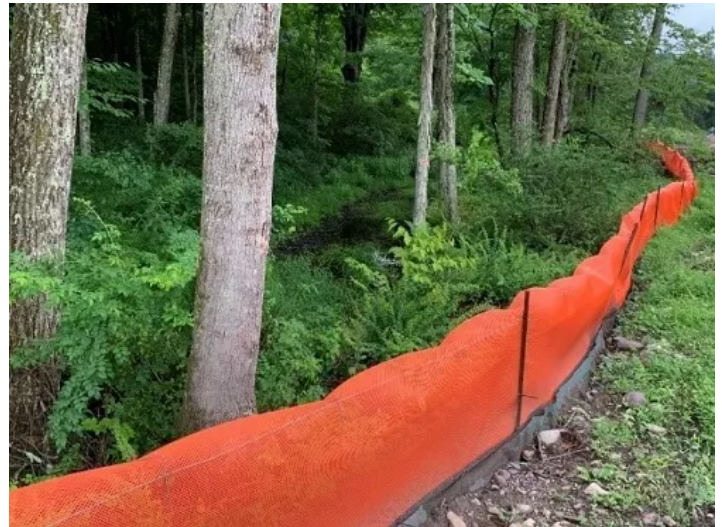
The orange critter fence seen above has black silt fencing on the lower portion to prevent soil from leaving the project area and is buried too deep for animals to dig under. The top portion of the fence folds back towards the outside of the project to prevent animals from crawling up and over.

One of the first things that was completed on the project was the installation of orange fencing around the area. This fencing serves several functions:

- It clearly marks the work zone;
- It prevents animals from crossing under, over, or through it;
- It has a silt barrier at the bottom to contain soils within the project boundaries.

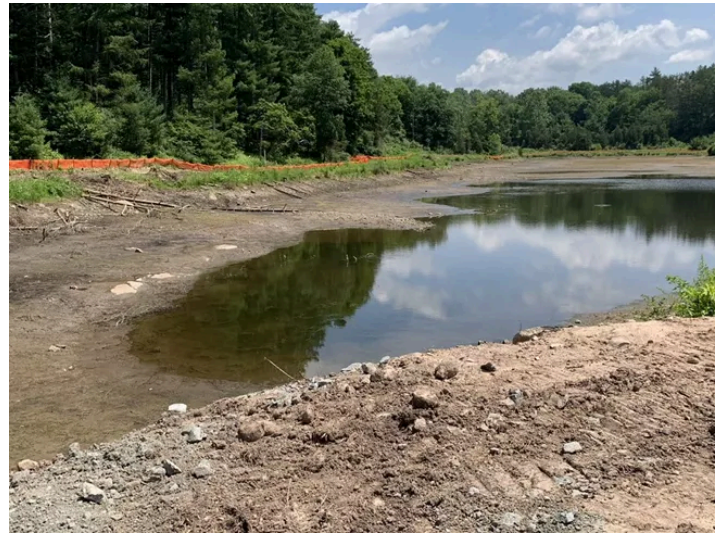
One of the ponds at Watergate Recreation Site that is in the process of being dewatered. The previous shoreline is exposed as the water recedes.

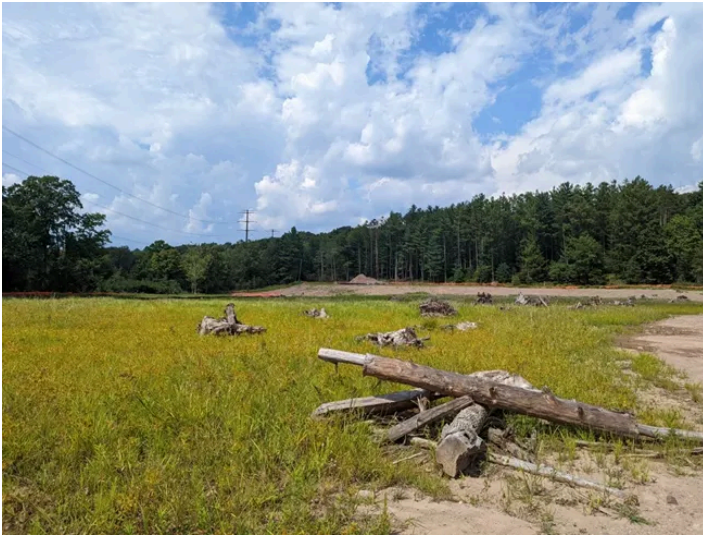
Wooden habitat structures scattered throughout an open and restored wetland.

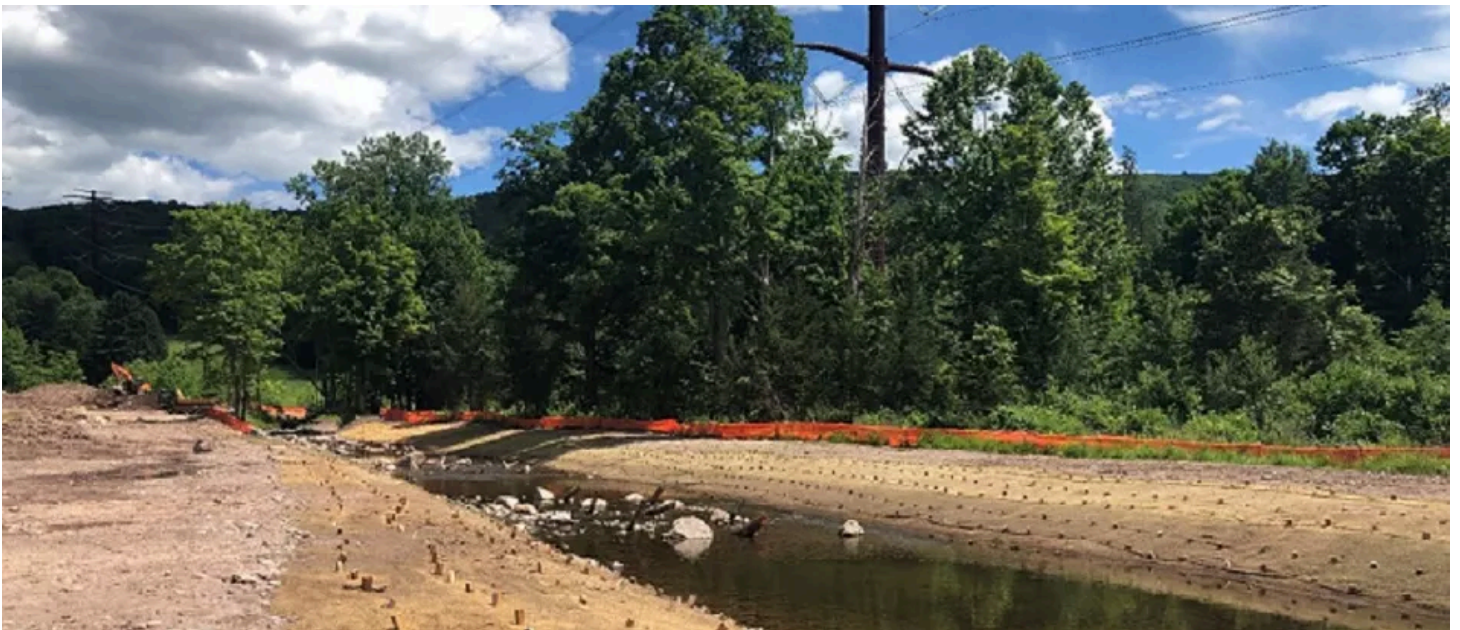
Van Campens Brook shortly after construction on the stream was completed. Erosion control matting is in place while native vegetation rehabilitates the area.
