## Juday creek restoration

### **Community Groups Work With Notre Dame Researchers to Restore a Creek Running Through New Golf Course**

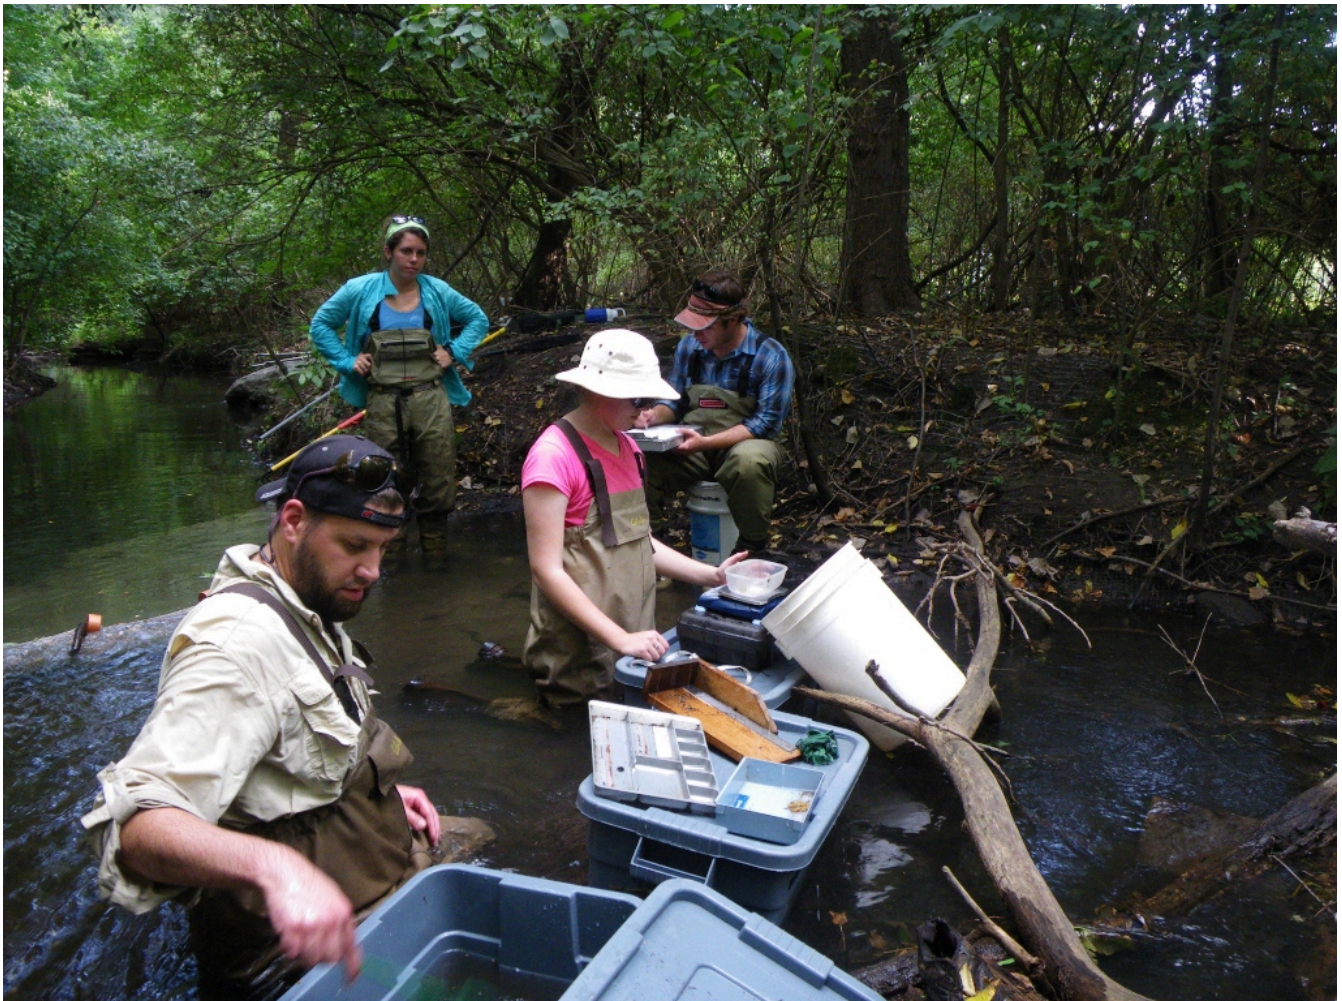
Member of the field crew monitoring fish populations in a restored section of the creek. Photo courtesy of Patrick Shirey

Researchers created a five-year plan to monitor the impacts of the restoration using the 60-meter sections. Once the engineering firm completed construction, the researchers began their monitoring plan. They conducted habitat surveys, measured water temperature, and conducted fish surveys.

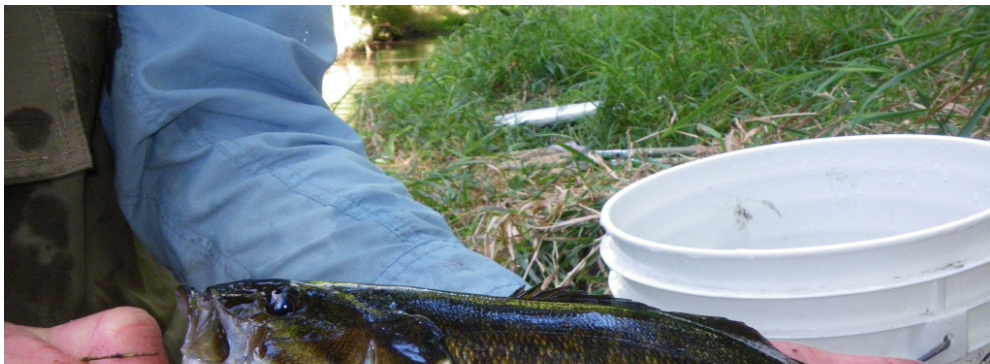
Juday Creek is healthier than it was previously. Through years of monitoring, the researchers noticed a change in the fish populations present. Although one of the initial goals was to protect the non-native brown trout swimming in the creek, the trout population decreased over time. However, native fish species such as largemouth bass, smallmouth bass, and rock bass are once again found in the creek and are increasing in abundance. Other native species like the johnny darter and mottled sculpin also returned. Many of these native species are intolerant to silt and pollution in the water, so their return is an indicator of increasing stream health. While upstream sections in the watershed have still seen negative ecological impacts from development, the restored section of the creek provides healthy habitat for many aquatic organisms.
