# Westmoreland Park

from **Engineering With Nature: An Atlas, Volume 2.**

## Portland, Oregon, United States

**Restoring an urban creek in the middle of a highly developed park.** A tributary of Johnson Creek, Crystal Springs Creek runs for 3.8 kilometers through Portland and is the coldest salmon-bearing stream in the city. But channelization for agriculture, large in-line ponds for irrigation, and urban development degraded the floodplain into a disconnected watercourse too warm for salmonids. In 2003, the City of Portland worked with the community to develop the Westmoreland Park Master Plan, which called for creating a healthier park environment for people and native wildlife. The project team, including Portland Parks & Recreation, the Portland Bureau of Environmental Services, and the U.S. Army Corps of Engineers, began by restoring 730 meters of Crystal Springs Creek. Completed in 2013, the restoration removed concrete curbing along the creek and pond's banks, removed the duck pond and replaced it with a wetland, and planted 15,000 native plants to shade the creek and prevent erosion. The project also added logs, pools, and riffles in the creek channel and more than 760 m

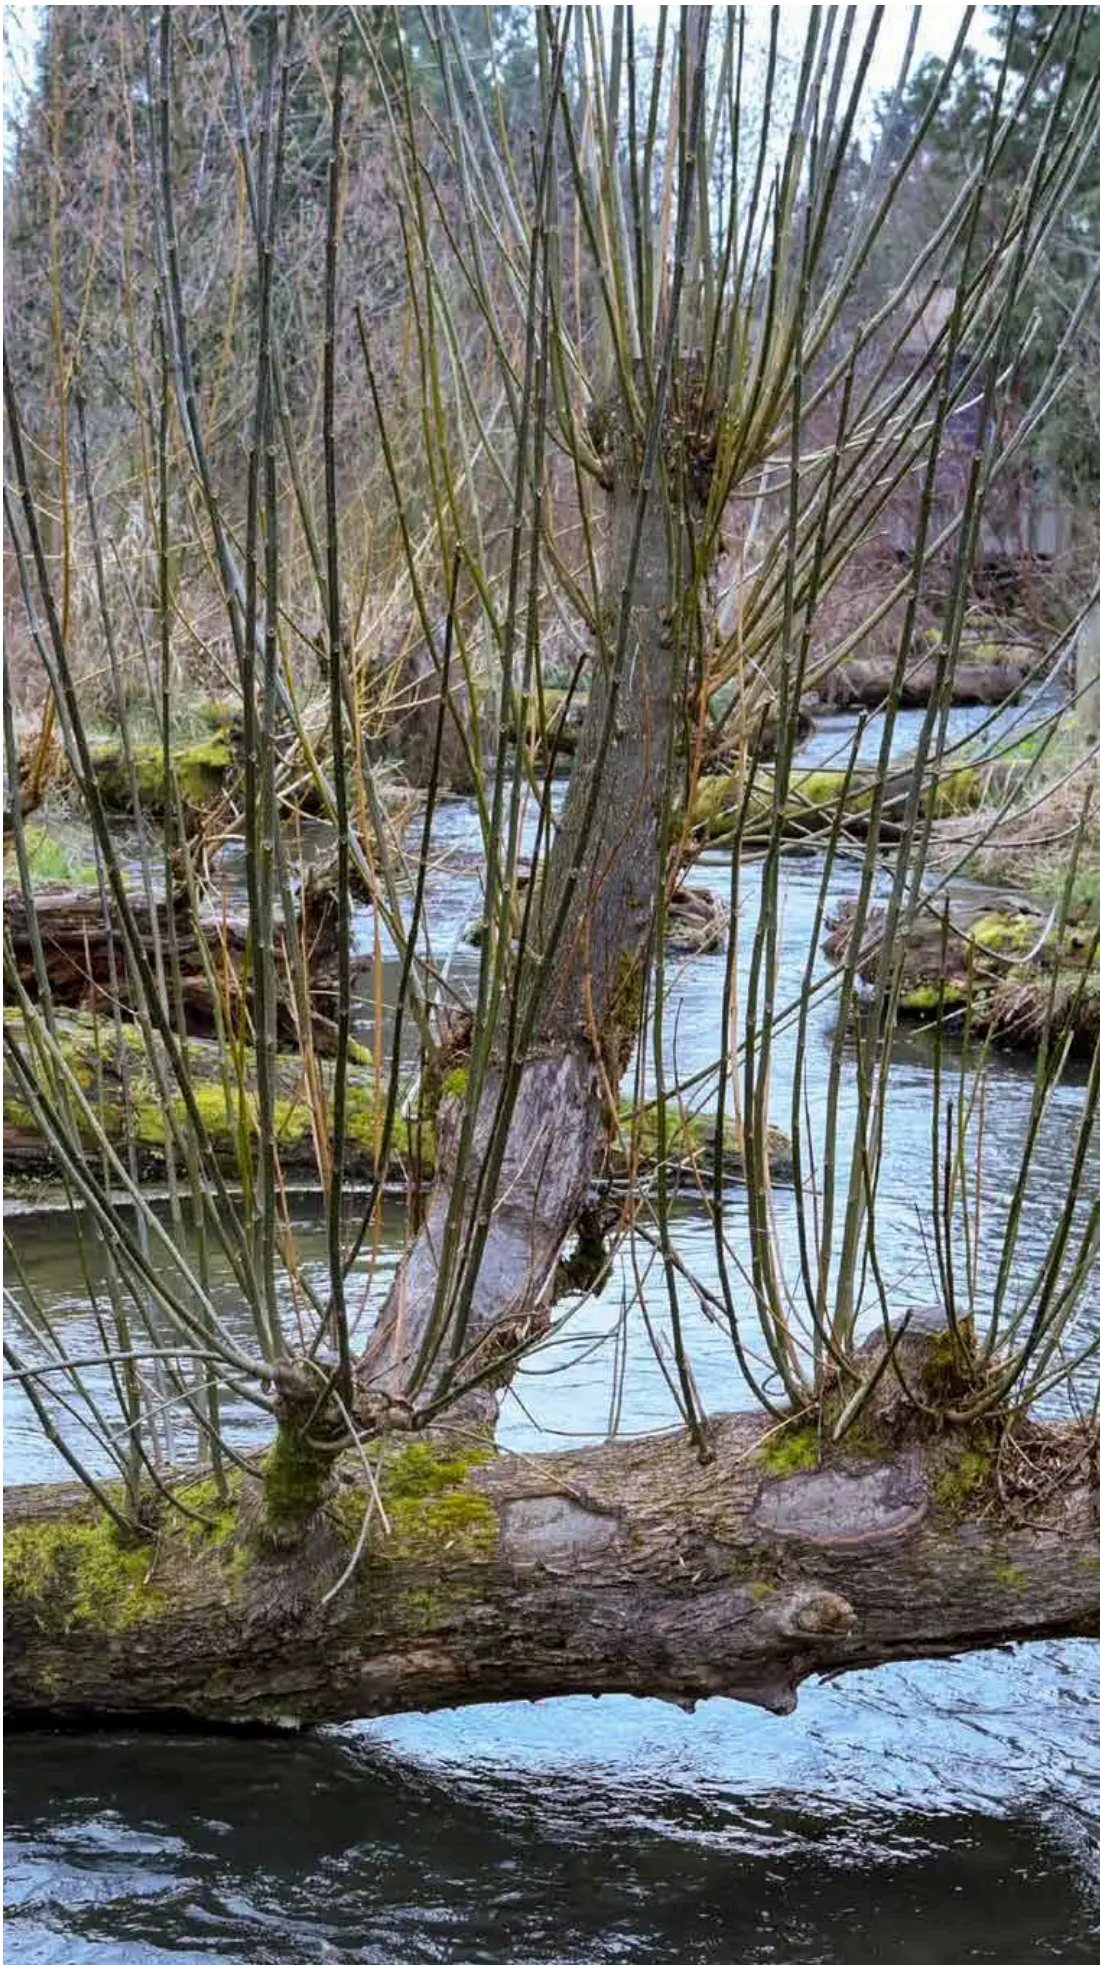
(Photo by Kerry Solan)

At the northernmost end of the park looking northward, the large woody debris provides habitat for native fish species.

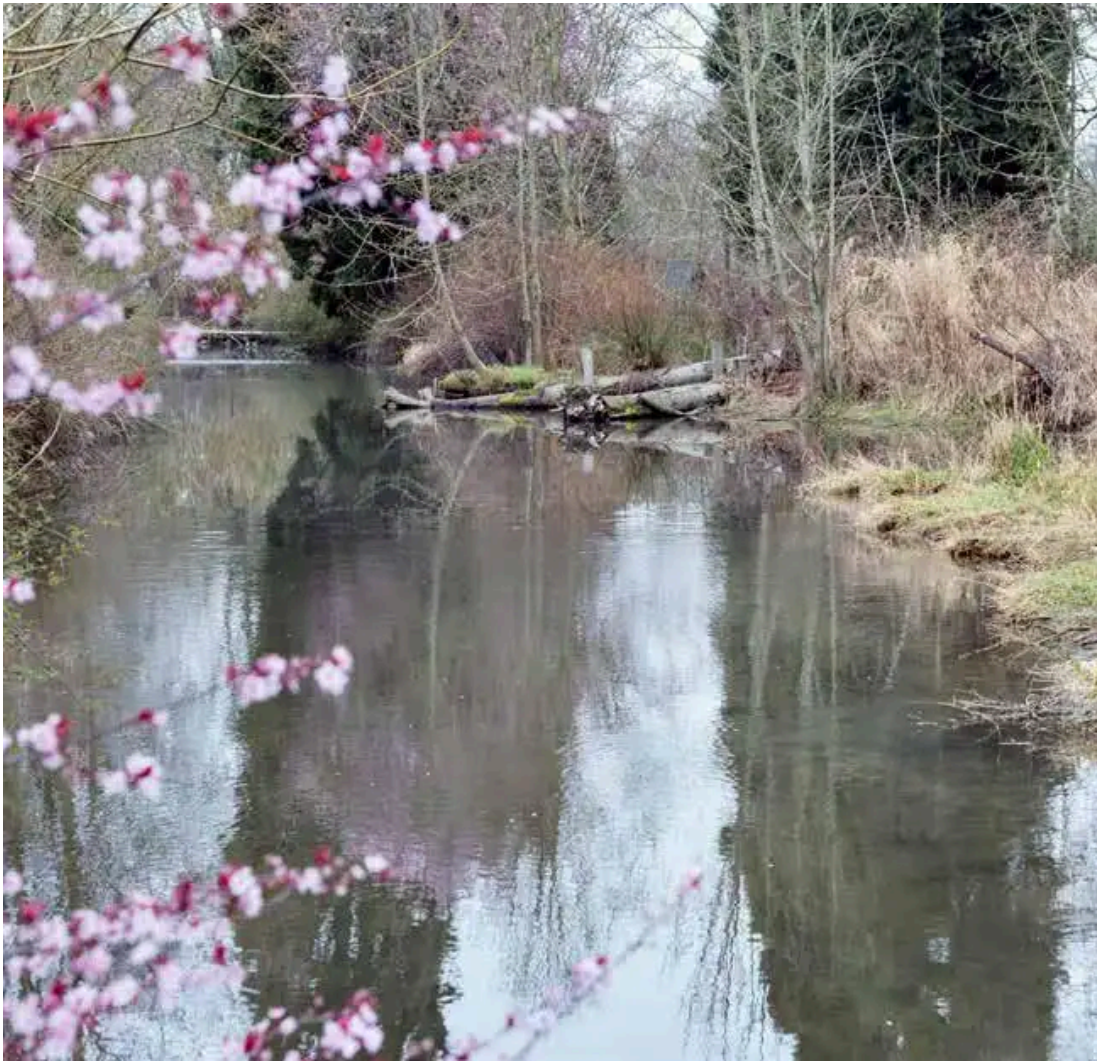
(Photo by Kerry Solan)

Southernmost end of the restored park looking southward.

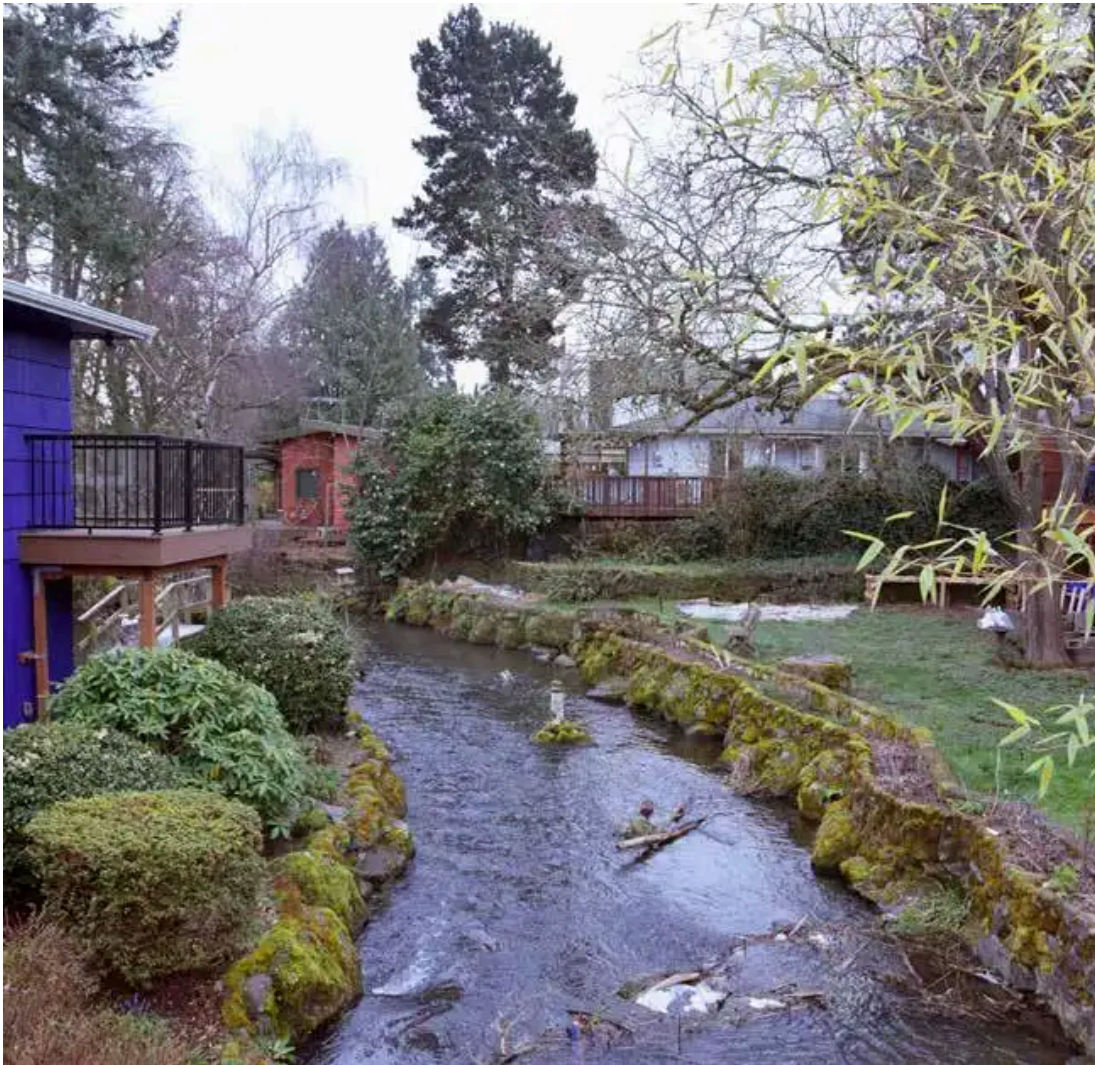
(Photo by Kerry Solan)

Woody debris, pools, and riffles in the restored Crystal Springs Creek just downstream of the Umatilla Street culvert.

The creek's path through the city meant the team needed to think creatively to engineer the restoration and to design the project so that flood elevations downstream did not rise. The team added large woody debris to the waterway without completely preventing access to this popular park, and they arranged the native plantings to make sure visitors could see into and through the wetland to the creek. Porous pavement managed stormwater and protected the water quality of the creek. To allow fish passage, they replaced the culvert under the nearby four-lane bridge, as it was not only undersized and a velocity barrier for fish but also inverted so the river flowed uphill through it.
