Coonamesett River

from **Engineering With Nature: An Atlas, Volume 3.**

by US Army Engineer Research and Development Center

Falmouth, Massachusetts, United States

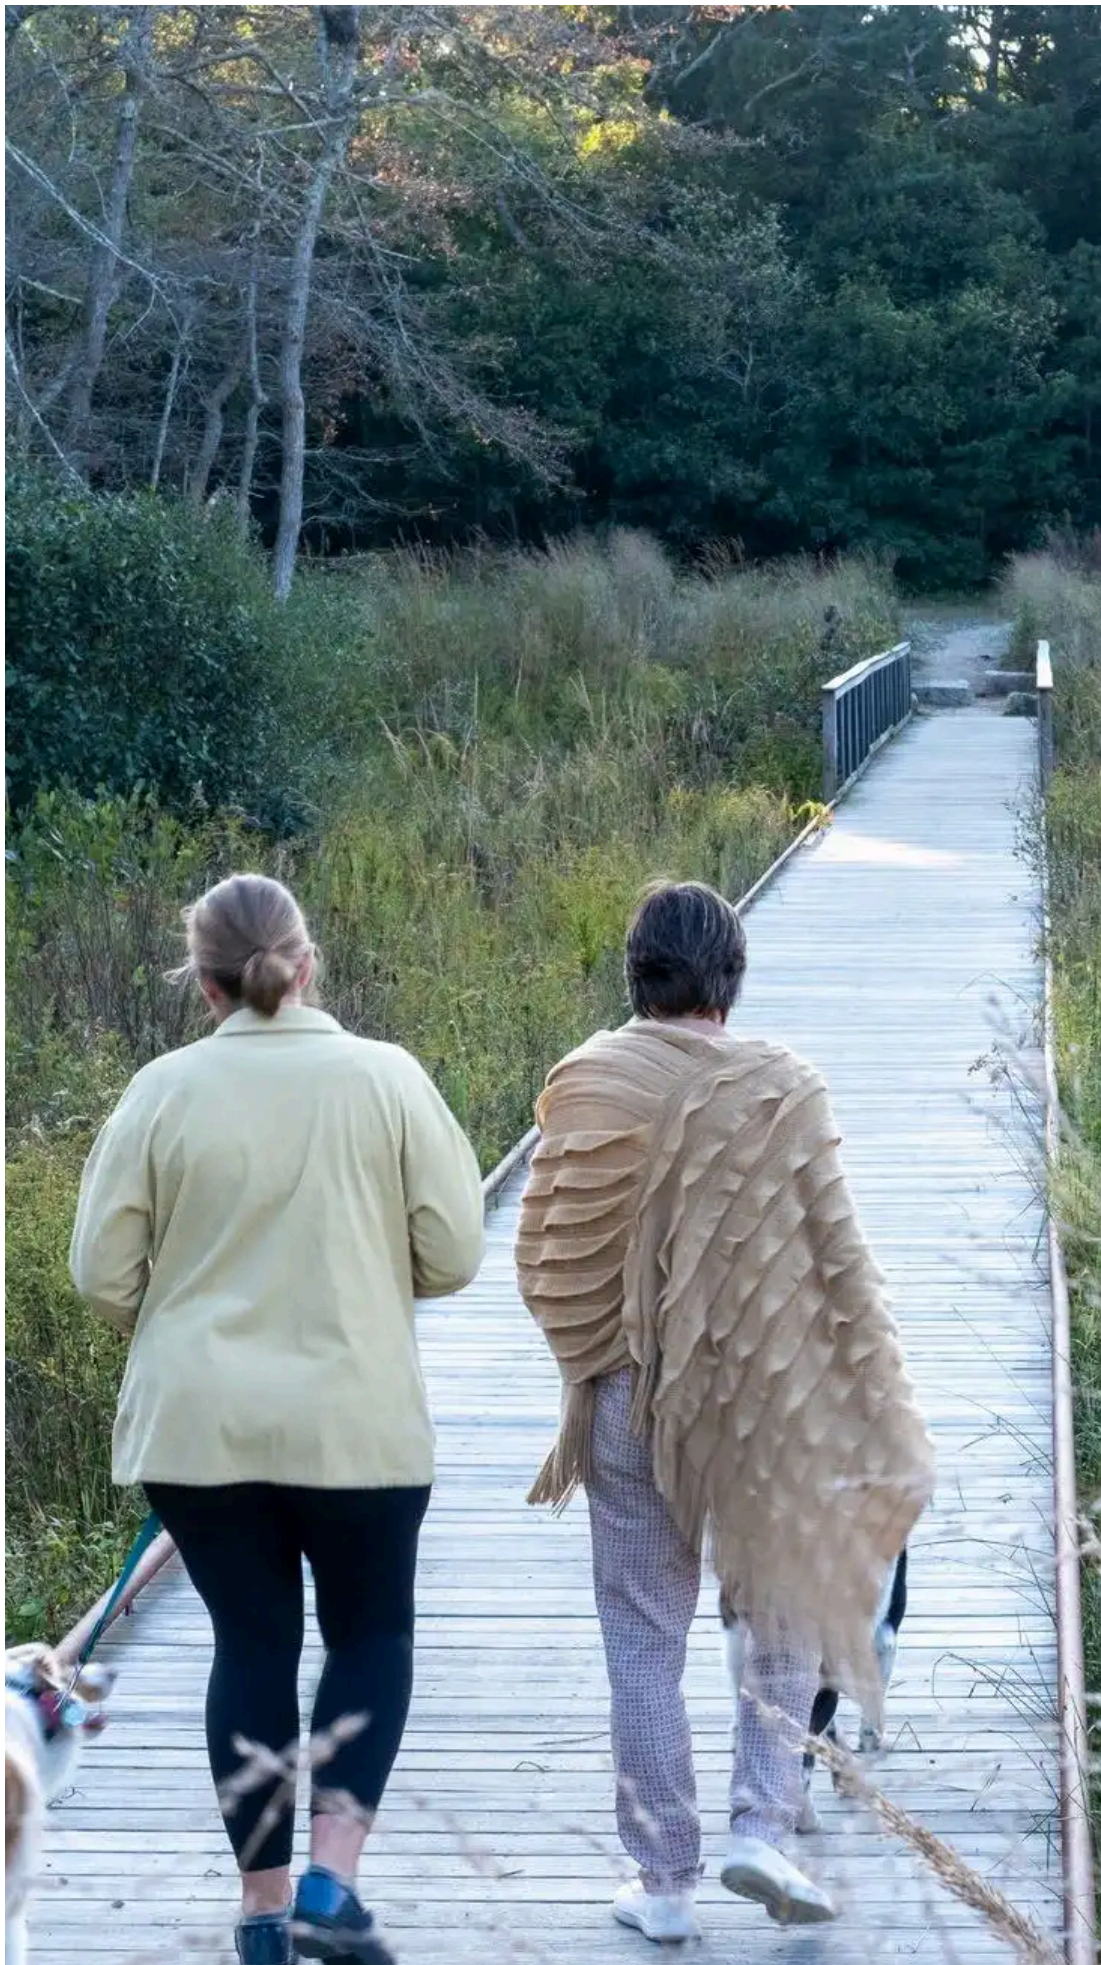
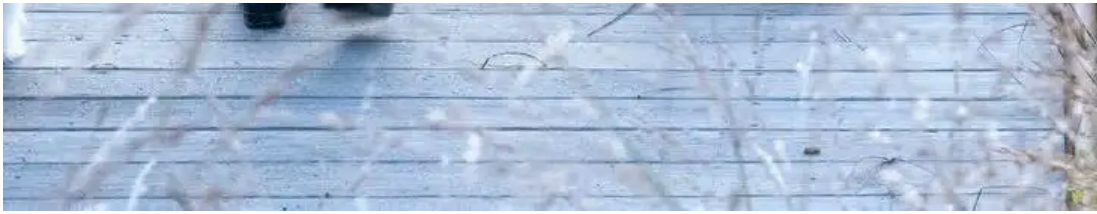
A system of raised boardwalks provides recreational access to the bogs while allowing fish passage. Previously, the river had been routed through a series of culverts.

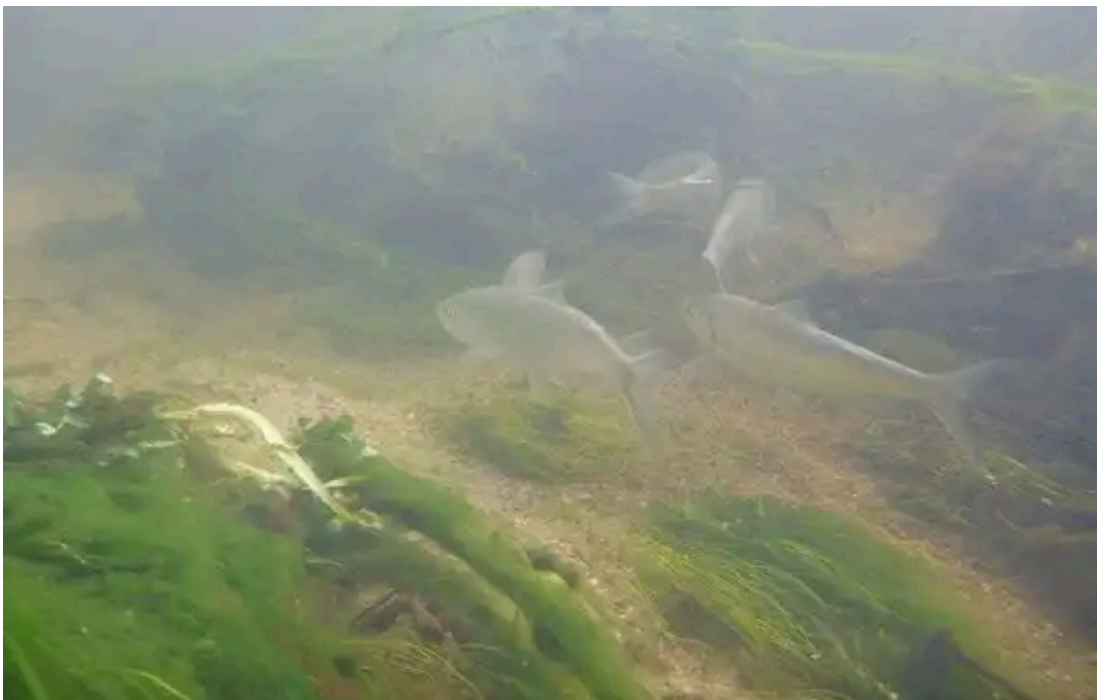
A school of herring was spotted in the river just a year after construction.

Removal of the legacy dams on the Coonamesett River and restoration of the associated floodplain and wetlands have several benefits, the most immediate being improved fish passage. Just a year after construction, herring (*Alosa* sp.) were migrating up the river, likely for the first time in over 300 years in an area historically used as a herring fishery. The restored channel's deep pools and cooler water provide habitat for brook trout (*Salvelinus fontinalis*), a species once found in the river and prized by anglers. And removing in-stream barriers, replacing undersized culverts, and restoring wetlands will help protect neighboring communities against flooding, especially as sea levels rise.

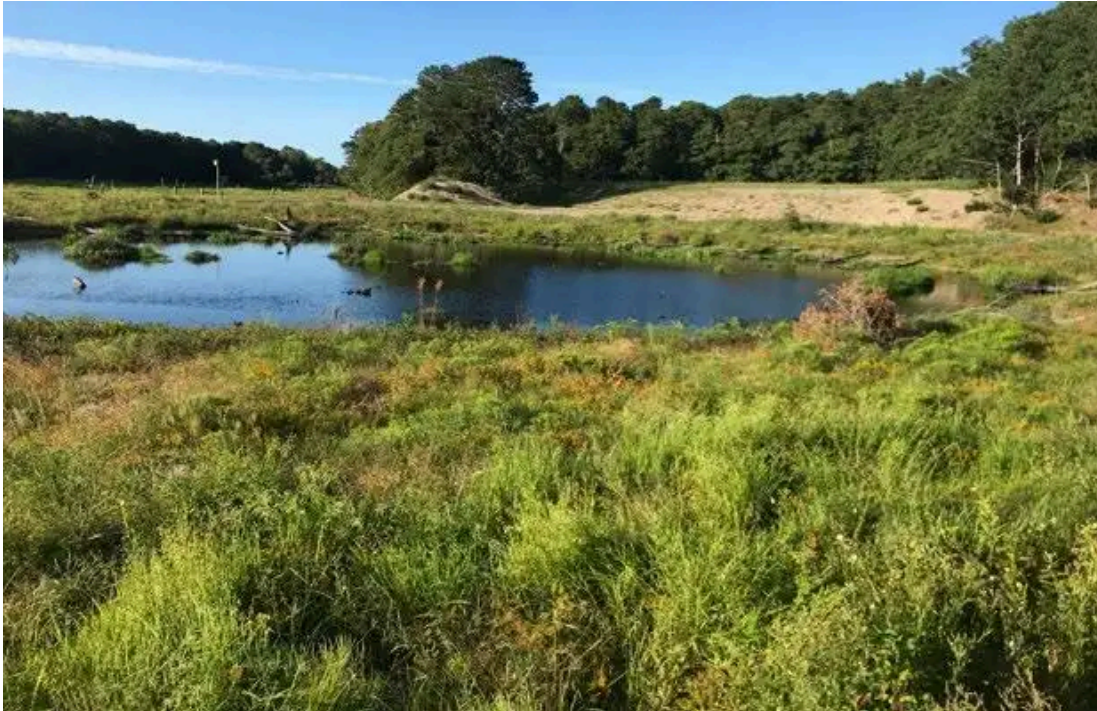
Sand excavated from the bog was used to create turtle nesting habitat alongside newly constructed ponds.

In the 1800s, some farmers began intentionally spreading sand over their cranberry bogs after noticing that harvests improved when the wind blew sand across their crops. The practice quickly spread across Cape Cod, making the area synonymous with cranberries in American culture but damaging river habitat. The sand prevented native plant growth and resulted in a wider, shallower channel. Excavating the sand, nearly a meter deep in places, improved habitat by making the river deeper and cooler. Potential sediment removal complications and costs were avoided by placing the excavated sand on adjacent hillslopes, where it provides nesting habitat for turtles.

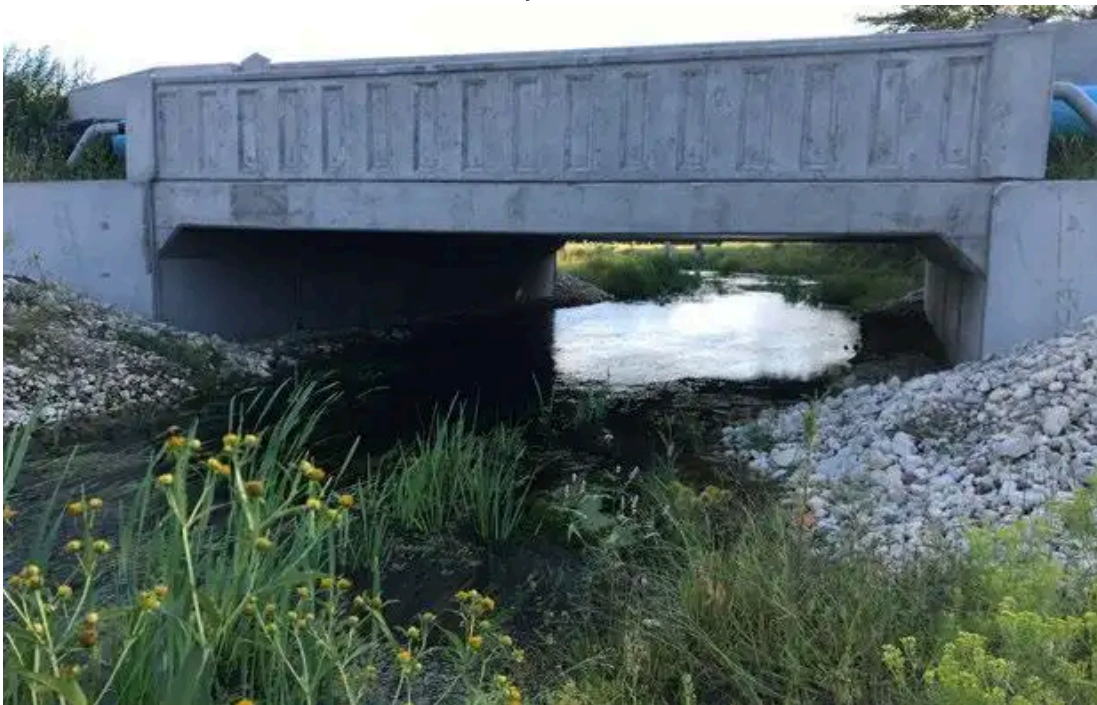
A new road crossing replaced three undersized pipes.
