## Chatfield Reservoir-Plum Creek

from Engineering With Nature: An Atlas, Volume 2.

by US Army Engineer Research and **Development Center**

#### Denver, Colorado, United States

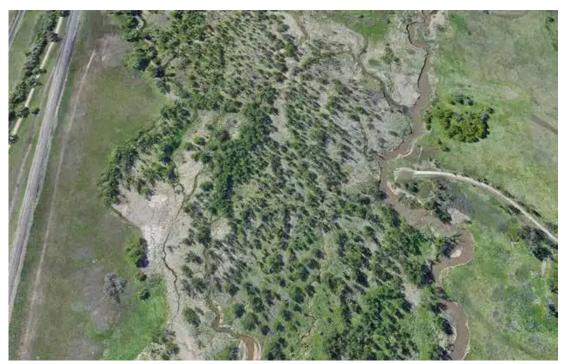
The same view as seen on the article cover but prior to restoration, 2017. (Image from Google Earth)

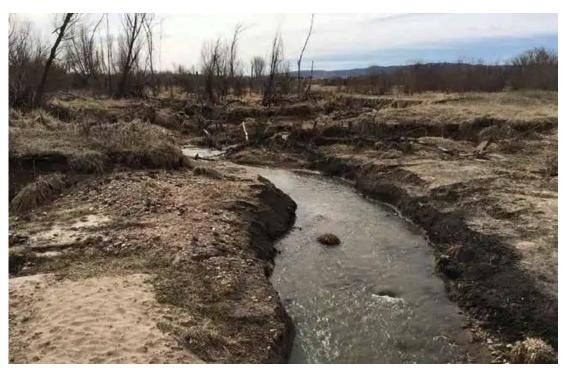
Incised Plum Creek and dewatered "dead" floodplain prior to restoration.

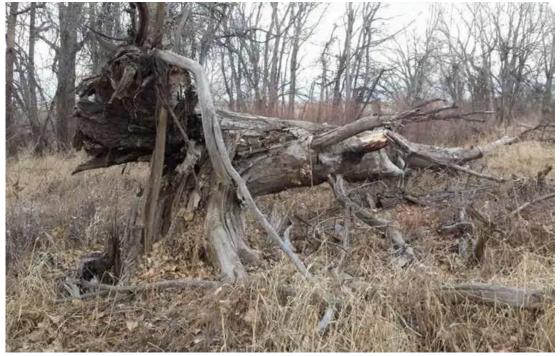
Repurposed tree anchored for habitat. (Photo by Clayton Ridenour, USACE)

to the floodplain. The project team used many of the removed trees to construct beaver-dam analogues to encourage local beavers to take up residence. Others they strategically anchored or used to armor the stream bank and outside bends, providing habitat for the Preble's meadow jumping mouse and for fish and other aquatic organisms. Restoring the streambed elevation on Plum Creek was a catalyst to reviving ecosystem processes, active beaver ecology, and a functional stream fishery.

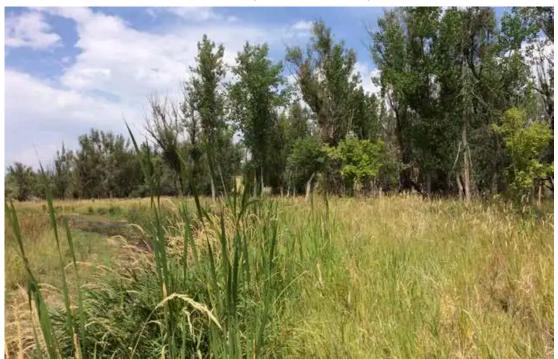
Floodplain wetlands and side channels respond quickly to restored water table at Plum Creek.
Restored braided and meandering side channels promote ecosystem resilience.

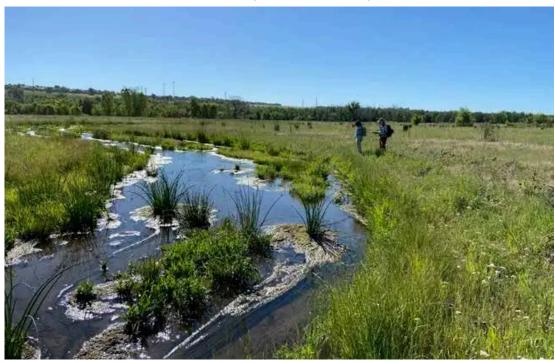
Monitoring and data collection during conditioning at Plum Creek.

The team removed and repurposed trees lost from degradation and dewatering effects; and the use of naturalized, void-filled riffle structures reduced the conditioning period that traditional solutions require. The conditioning period brings an increased risk of failure, so to further reduce this risk, the team developed a high-resolution, spatially referenced monitoring and adaptive management program to rapidly communicate restoration status during the conditioning phase. Data from restoration monitoring crews upload immediately to a master database. Access to near real-time monitoring data facilitates adaptive decision-making to improve restoration efficiency.
