# Prime Hook Wildlife Refuge

from **Engineering With Nature: An Atlas, Volume 2.**

by US Army Engineer Research and Development Center

## Milton, Delaware, United States

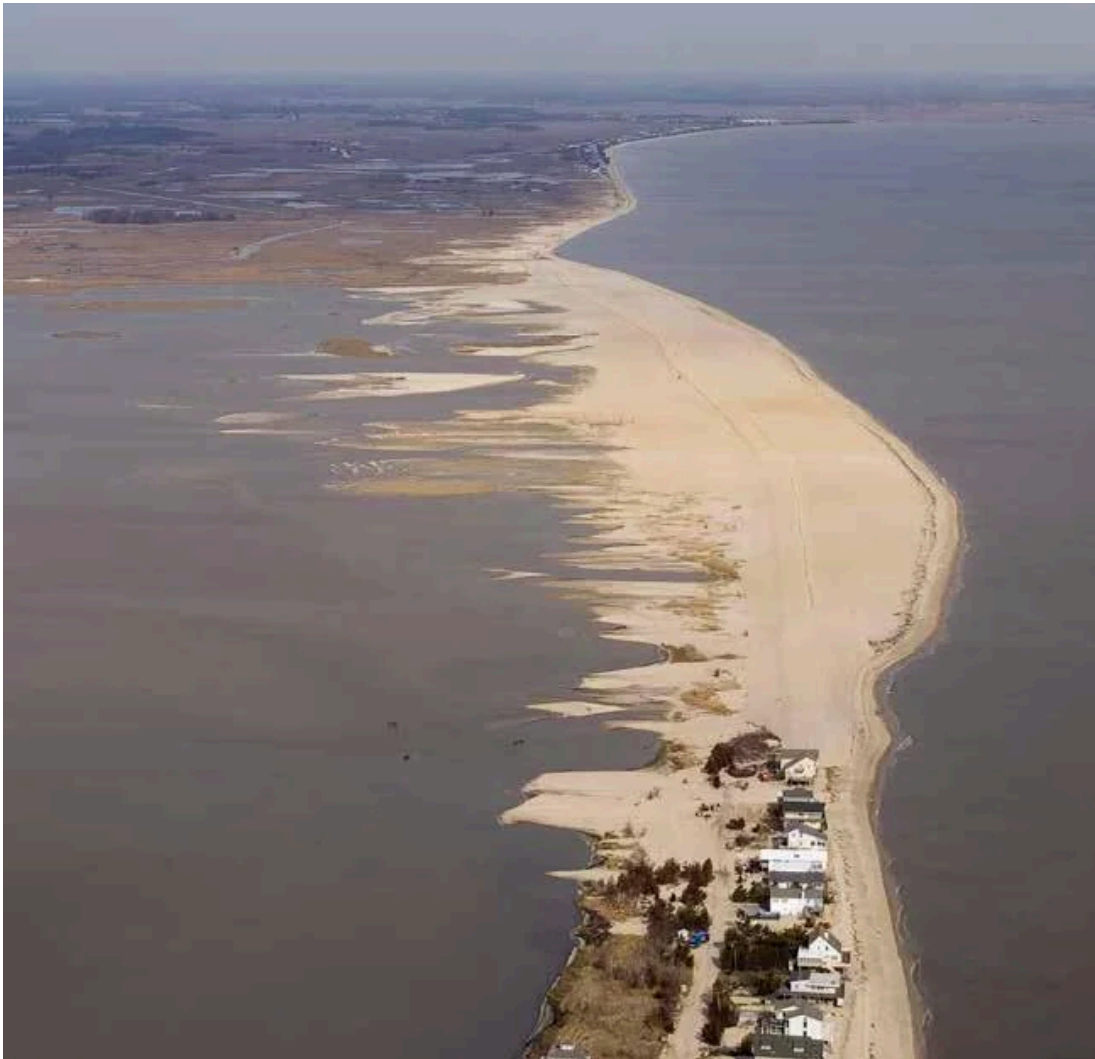
An aerial view of the completed project, with flooded refuge at left.  
(Photo by TI Coastal Services Inc., courtesy of Norfolk Dredging Company)

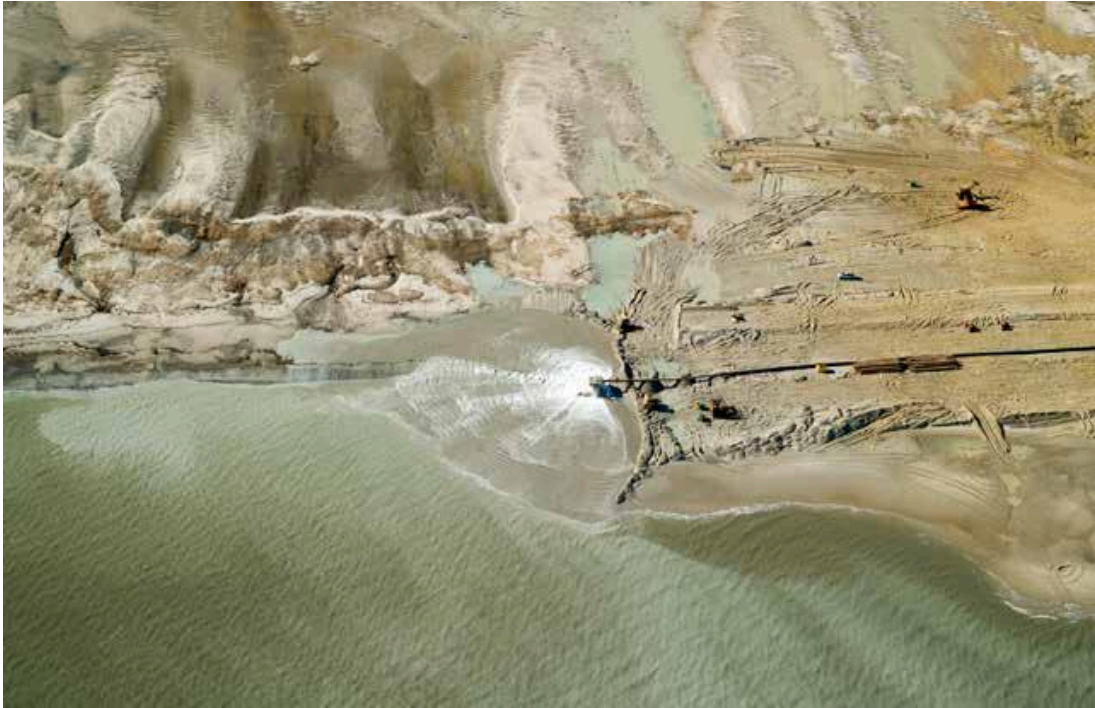
Bulldozers spreading sand after it is pumped onto the beach  
(Photo by TI Coastal Services Inc., courtesy of Norfolk Dredging Company)

channels. In total, the team moved over 1.08 million cubic meters of sand to recreate 2,700 meters of shoreline.

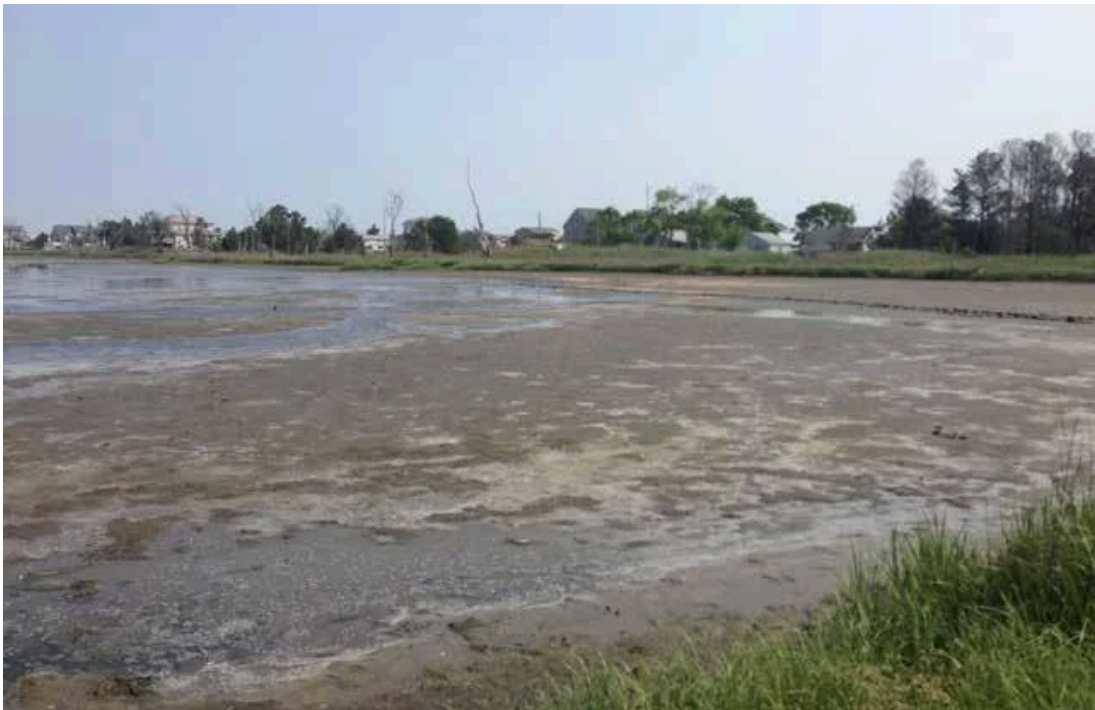
Preconstruction mudflats just after waters receded.  
(Photo by U.S. Fish and Wildlife Service)

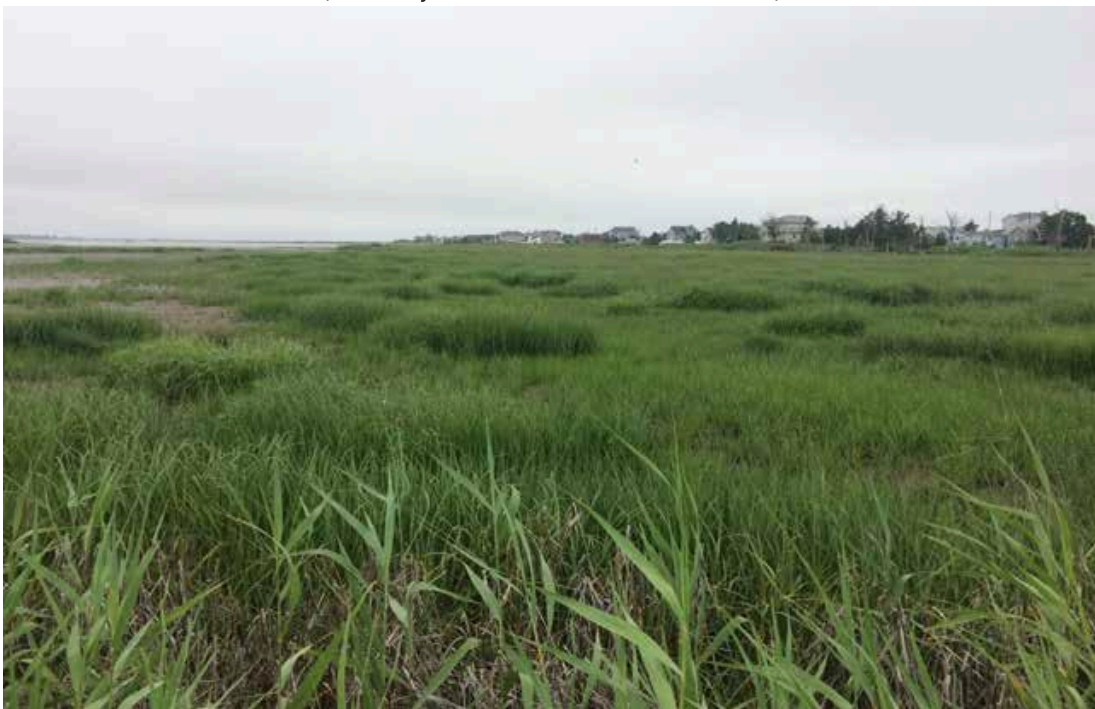
The same mudflats two years postconstruction.  
(Photo by U.S. Fish and Wildlife Service)
