North Sandy Pond

from **Engineering With Nature: An Atlas, Volume 3.**

Sandy Creek, New York, United States

Placing dredged sand to repair barrier bar breaches. The northern barrier bar in North Sandy Pond was severely eroded by very high lake levels and storms in spring 2017. Washovers were common, and the barrier was in danger of being breached. A breach would have exposed wetlands and properties to strong waves and increased the risk of floods and erosion. Additional breaches would have threatened to dissolve the barrier bar itself, endangering public and private lands on shore and in the pond. A similar process occurred throughout the 1970s and was expected to recur without intervention. Changes in the shape and nearshore dynamics of the barrier bar had caused sand from the eroded beach to accumulate in a 611,644-cubic-meter shoal adjacent to the channel connecting North Sandy Pond to Lake Ontario. Further expansion of the shoal threatened to close the channel, blocking the exchange of water between the pond and the lake and degrading water quality in the pond. This project used local natural materials to replenish a barrier bar sheltering businesses, homes, and wetlands fro

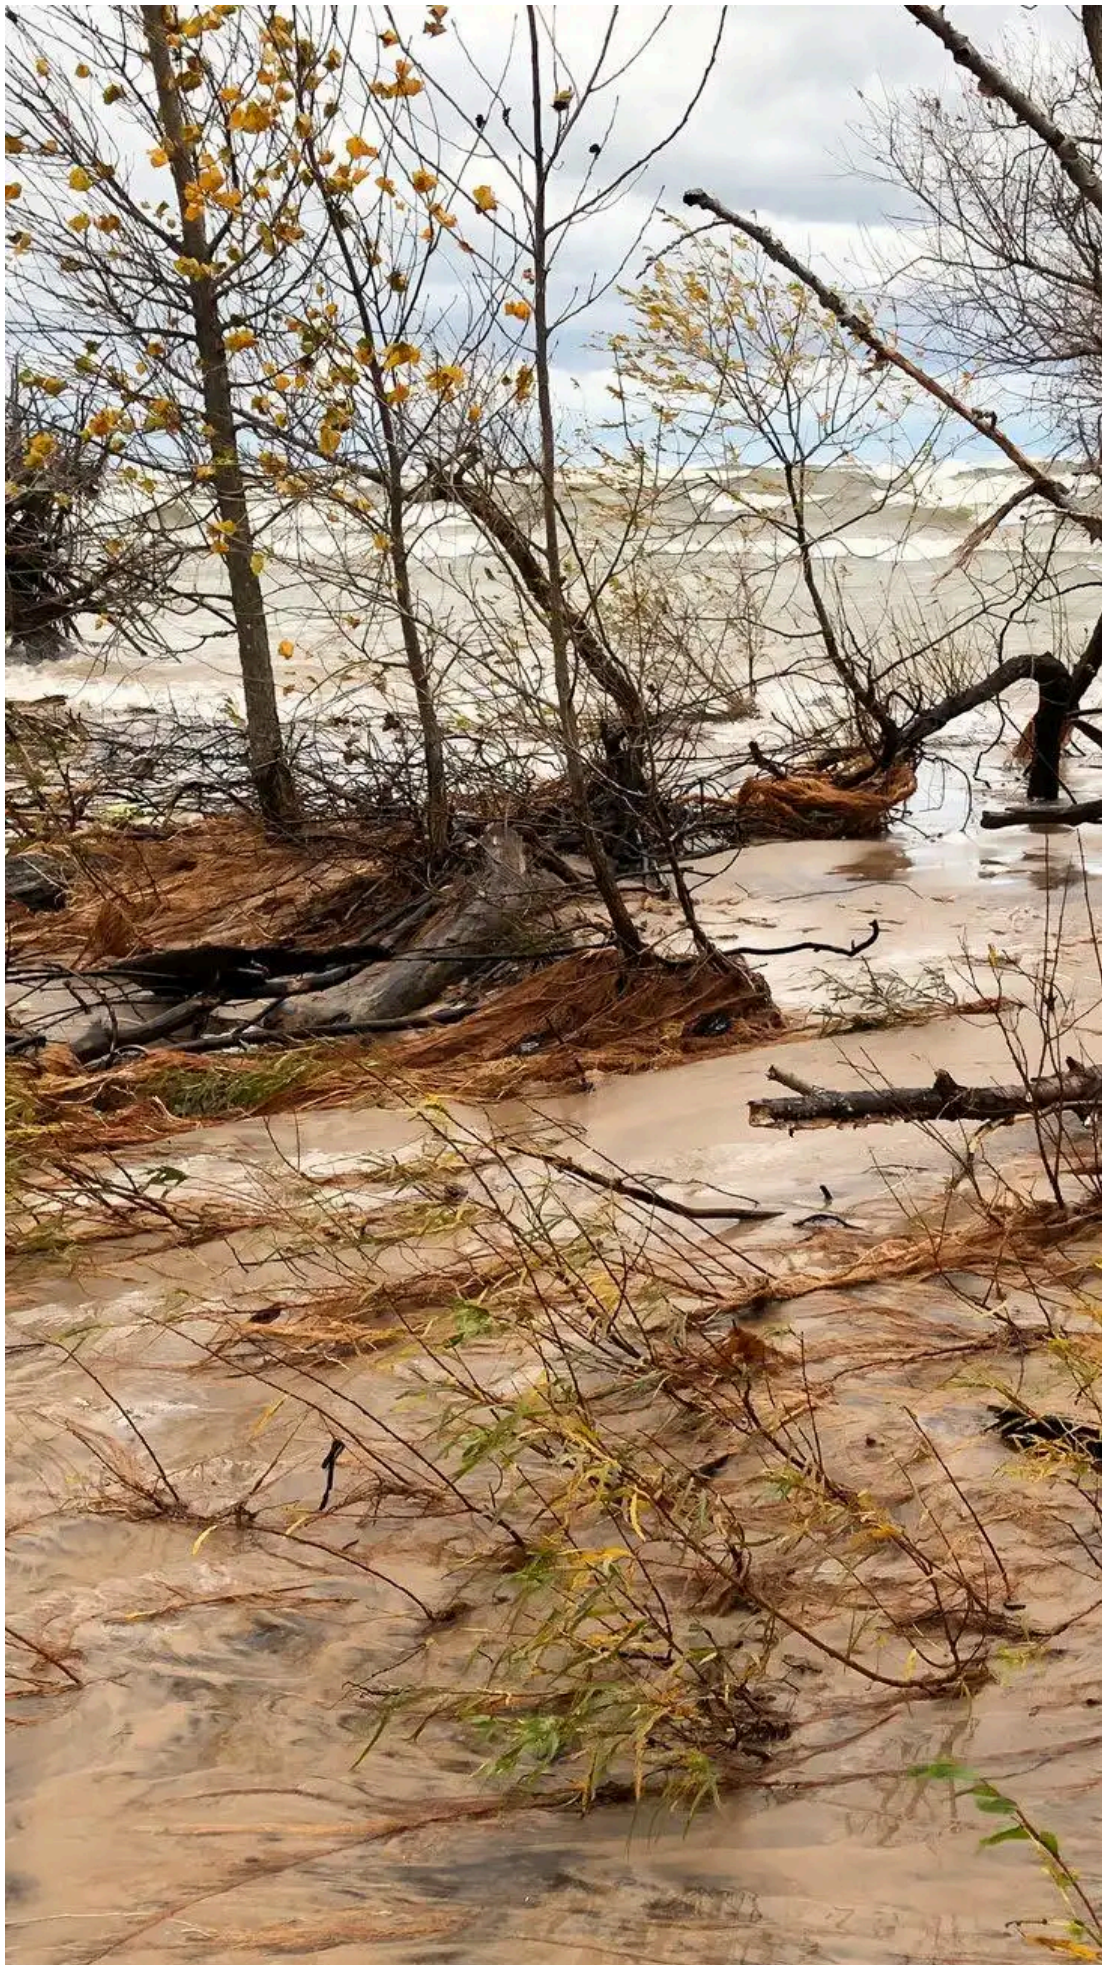
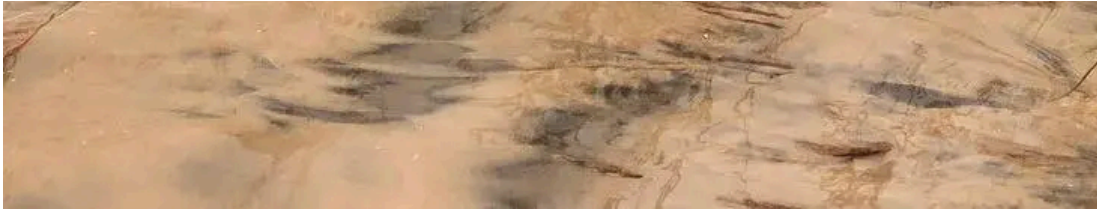
Previously overwhelmed area in a low-lying part of the north barrier during the “Halloween storm” of November 2019, when levels of Lake Ontario were very high.

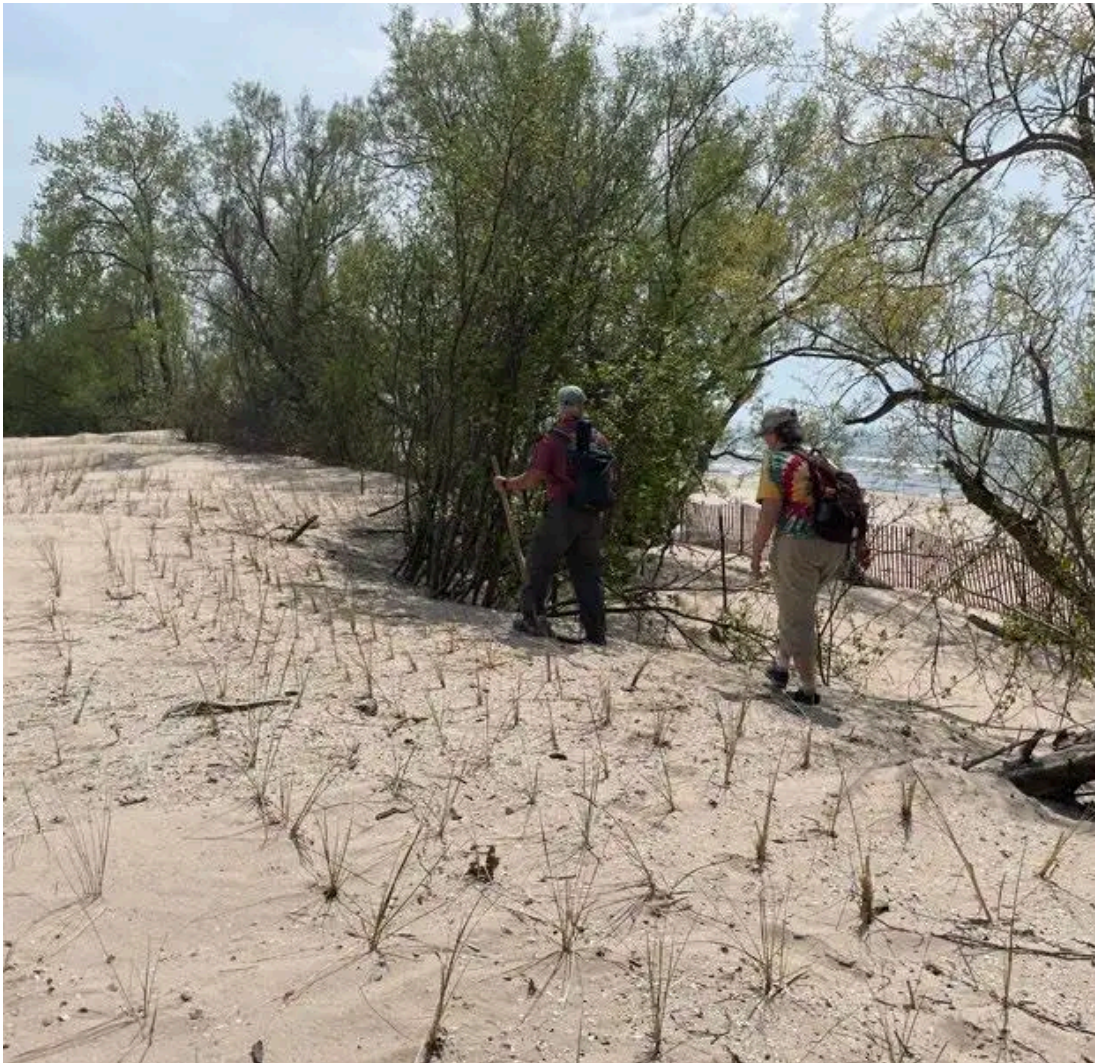
The newly constructed dune with dredged sand and rows of transplanted beach grass. This dune has continued to accrete with sand from aeolian drift captured by the beach grass.

Community engagement was critical in strengthening the barrier system, benefiting businesses and the pond’s recreational economy. After 915 meters of sand fencing was installed, 126 volunteers contributed more than 544 hours to dig and transplant existing beach grass and plant 35,000 native beach grass shoots along 488 meters of shoreline in 2020 and 2021. Additional project benefits realized for the community’s quality of life included access to a beautiful walkable beach; a crucial shelter to marinas, restaurants, and shoreline property from the full force of Lake Ontario; and a restored barrier beach, which stabilizes the channel flanked by state park lands, providing a recreational destination that serves over 3,000 boats.

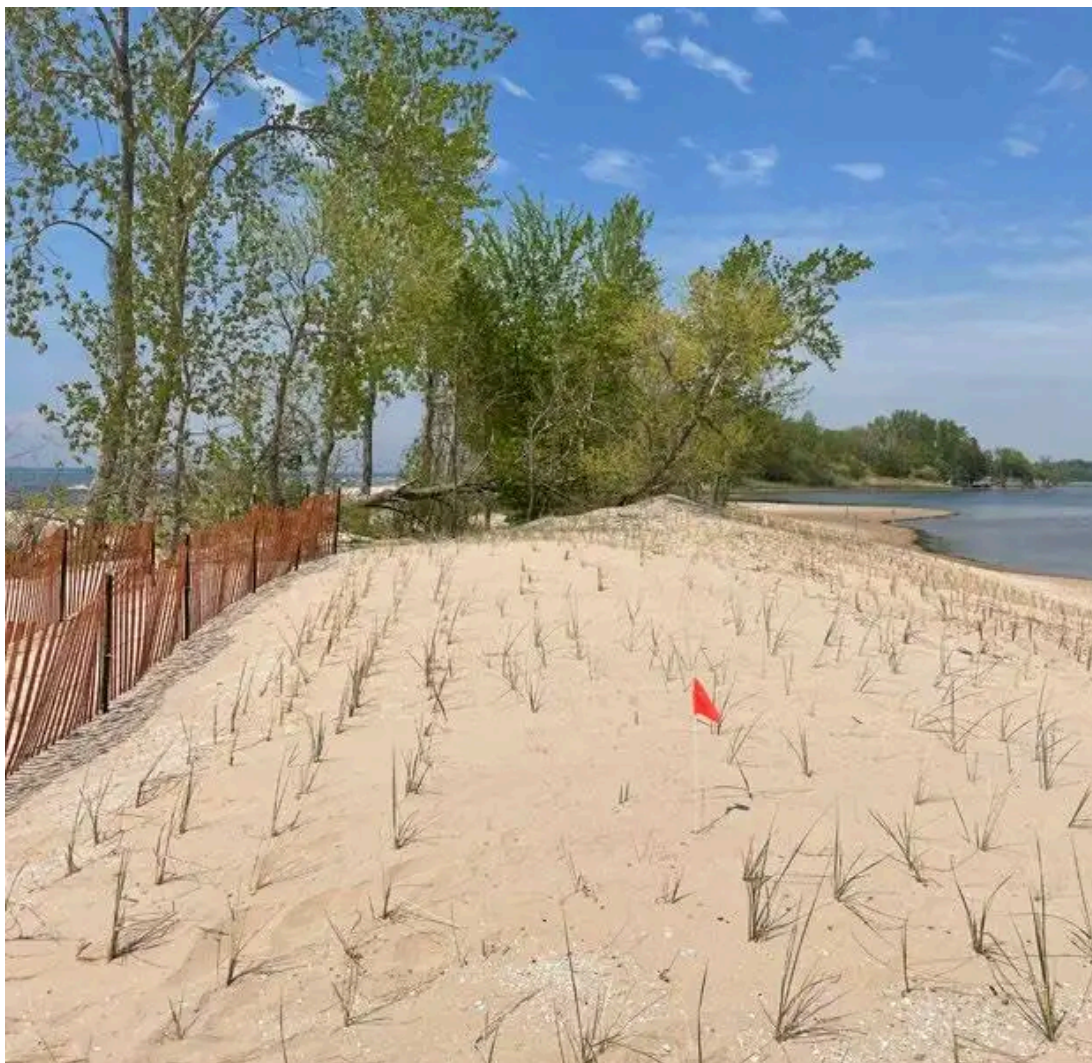
Beach grass planted on the newly restored dune. About 60,400 cubic meters of sand have been dredged from the shoal and moved to this beach in heavy trucks and shaped with a bulldozer.
