Wagon Hill Farm

from **Engineering With Nature: An Atlas, Volume 3.**

Durham, New Hampshire, United States

Constructing New Hampshire's first living shoreline. The Wagon Hill living shoreline project addressed the loss of almost 30 centimeters per year of fringing salt marsh due to foot traffic from people and dogs, soil ice needles, wind-driven ice, tides, boat waves, and shade from nearby trees that prevented the growth of marsh vegetation. Decades of erosion had created a shoreline scarp approximately one meter high. Rather than fill in the mudflats with a long, gentle slope leading up to the remaining marsh, project designers opted to build out the marsh approximately nine meters into the mudflats and grow new salt marsh to replace what had been there 25 years earlier. The project has three planting zones: low marsh (mean tide to mean high water), high marsh (mean high tide to mean higher high water [MHHW]), and a tidal buffer zone above MHHW. Trees were removed so sunlight could reach the new marsh plants. A nearly vertical rock sill incorporating root wads in places was constructed as the new shoreline. Fencing above the tidal buffer and extending into the water protects t

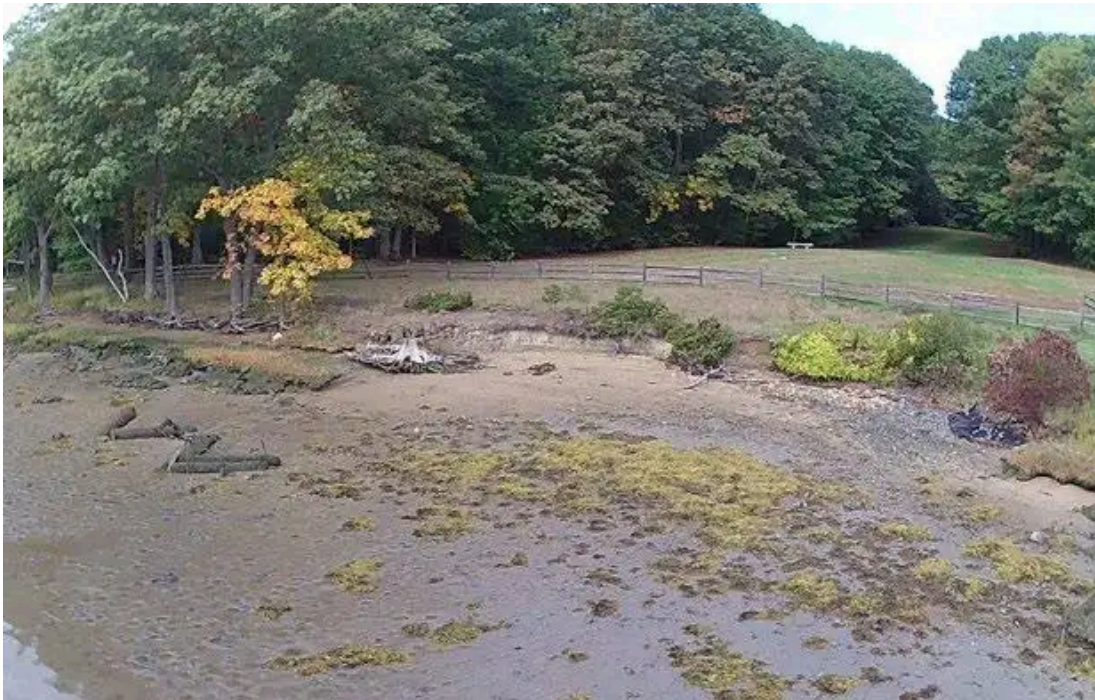
Aerial view of the prerestoration shoreline and fence.
(Photo by Michael Lynch, Durham Public Works Department)

The retreat of the Wagon Hill shoreline and loss of salt marsh plants was remarkable. One fence was moved back at least eight meters in 25 years, and pins along the shoreline measured an annual average erosion rate of almost 30 centimeters. Game cameras recorded people and dogs walking on the marsh daily and small waves removing sediment from the shoreline. Light at the tree line was insufficient for marsh vegetation. Winter ice broke apart shoreline soil, promoting erosion when the banks thawed. Ice also shoved against the banks and undercut marsh blocks. Sea level rise outpacing marsh accretion exacerbated shoreline erosion.

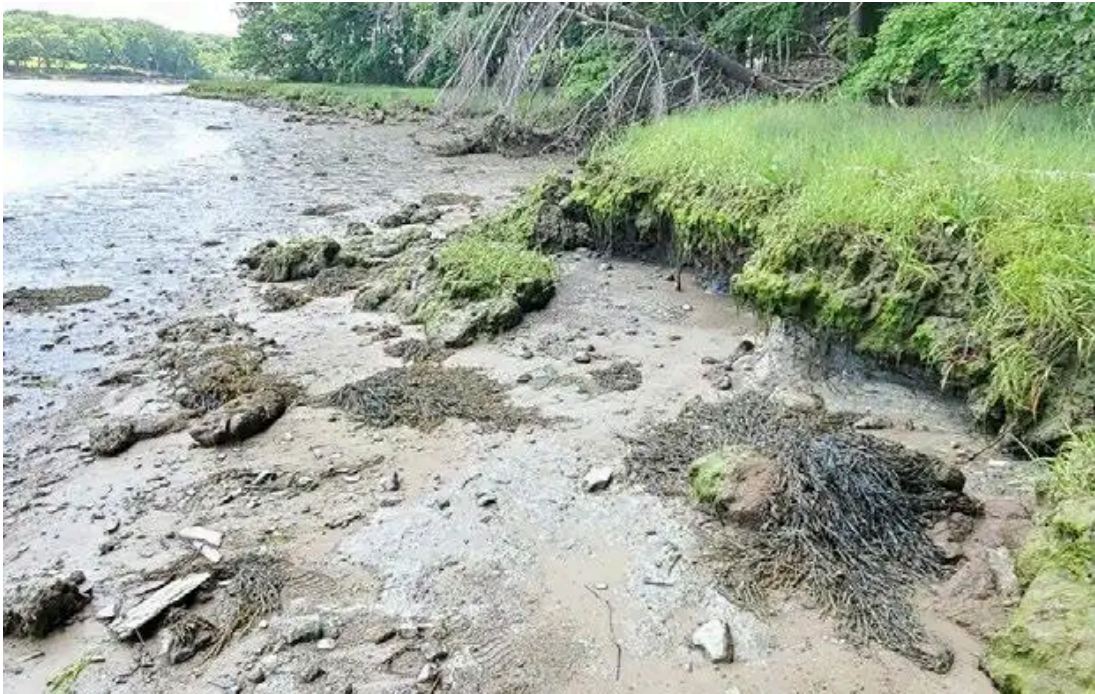
Prerestoration marsh erosion.

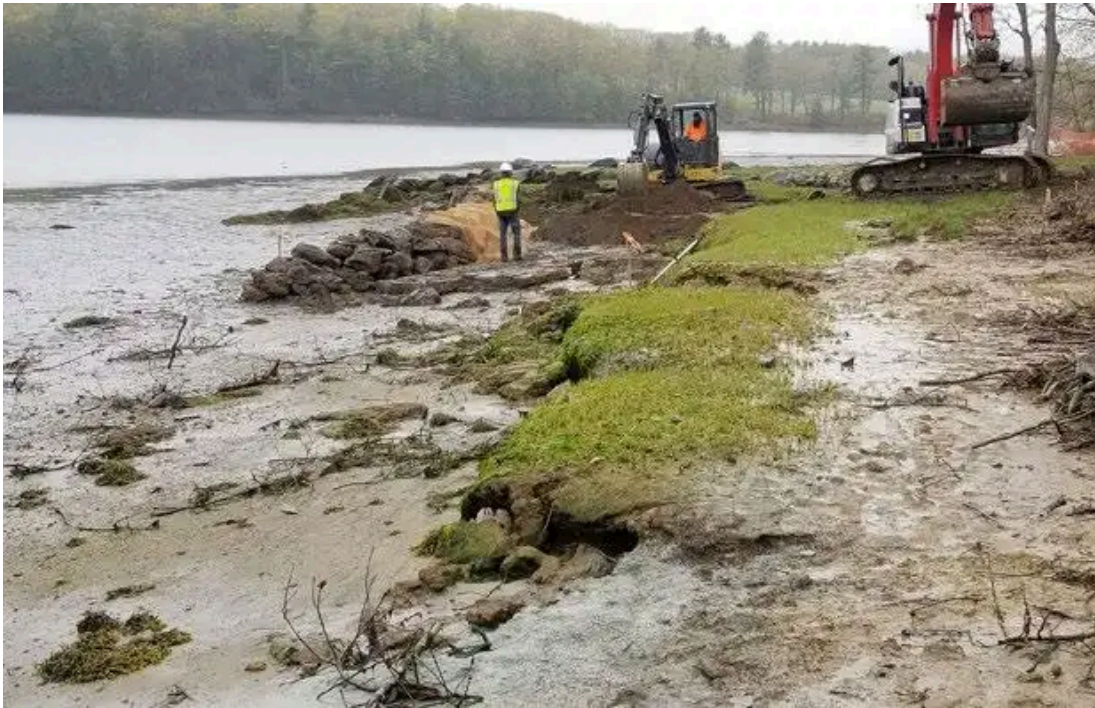
Sill and marsh construction.

A perimeter fence protects the restored salt marsh from people and dogs. Gentle marsh slopes limit outgoing tide velocities. Rocks provide perches for birds, break up blankets of ice, and prevent ice rafting of surface sediments and vegetation. Coir logs parallel to the shoreline permit marsh inspections without trampling plants and interrupt erosion rill formation until full salt marsh vegetation coverage occurs. The plants also dramatically reduce boat and wind waves. Root wads and the rock sill arrest marsh edge erosion; the sill withstands ice shoving and waves. A shoreward tidal buffer accommodates marsh migration as sea level rises. Tree removal improved light on the marsh.

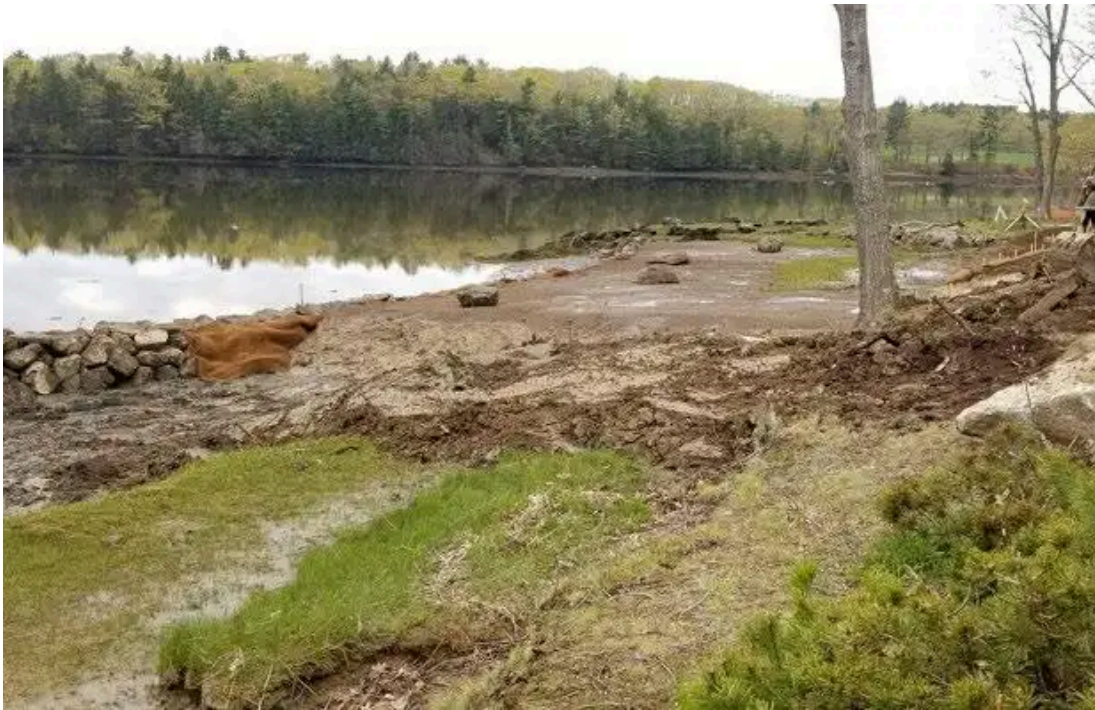
Sill and marsh construction with habitat boulders that provide perches for birds but, more important, break up large ice sheets and prevent ice rafting of marsh plants and sediments.

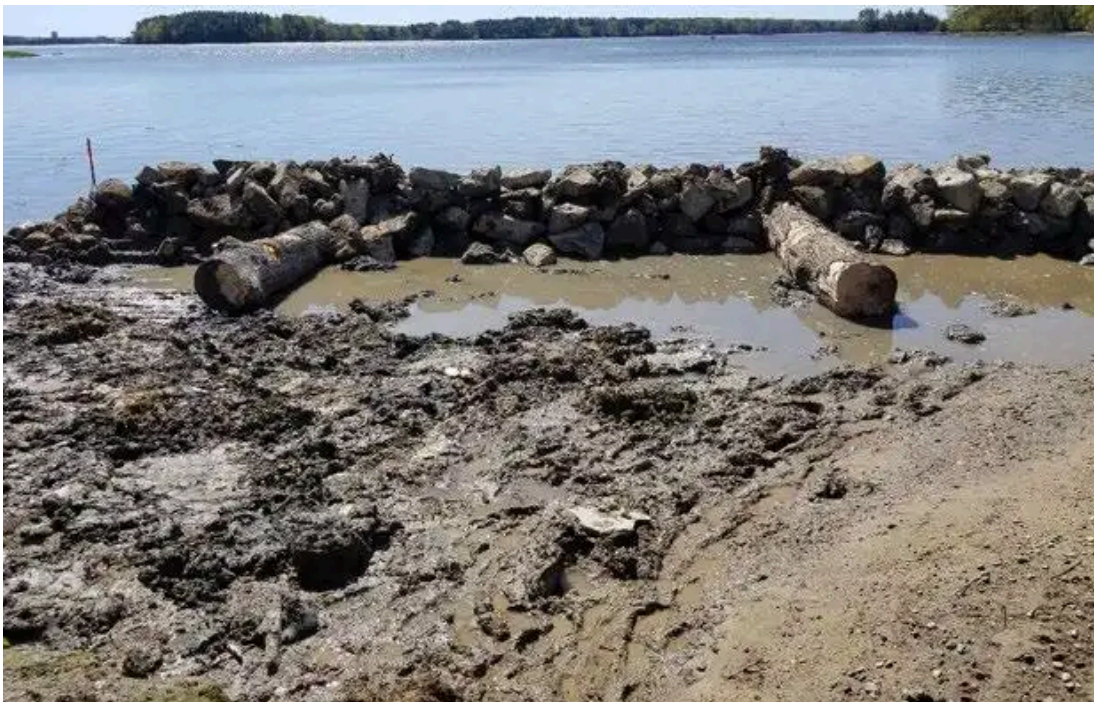
Sill and root wads incorporated into the rock sill to provide microtopography that leads to local hydraulic and habitat diversity.
