# **Case Study:**

# SOUTH CAPE MAY MEADOWS, CAPE MAY POINT, NEW JERSEY

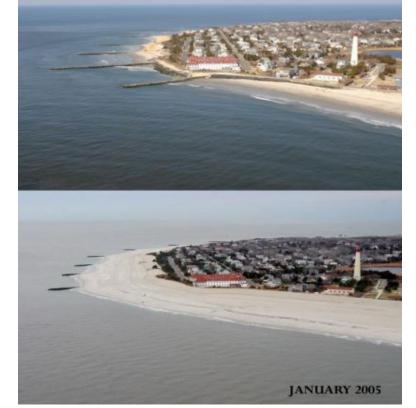
Beach replenishment on the state park beach and around Cape May Point, before (top) and after (below) the restoration. Source: U.S. Army Corps of Engineers 2007.

During the first phase of the project nearly 1,400,000 cubic yards of sand were used to construct a 1-mile long, 18-ft tall sand dune and widen 2 miles of beach. During the second phase, freshwater wetlands were restored and drainage culverts were added to improve water flow, quality and draining — thereby increasing their ability to prevent flooding.
