A Community Effort Stems Runoff to Safeguard Corals in Puerto Rico

In Culebra, Puerto Rico, the community used green infrastructure to decrease coastal erosion and mitigate damage to their near-shore coral reef.

Case Studies > A Community Effort Stems Runoff to Safeguard Corals in Puerto Rico >

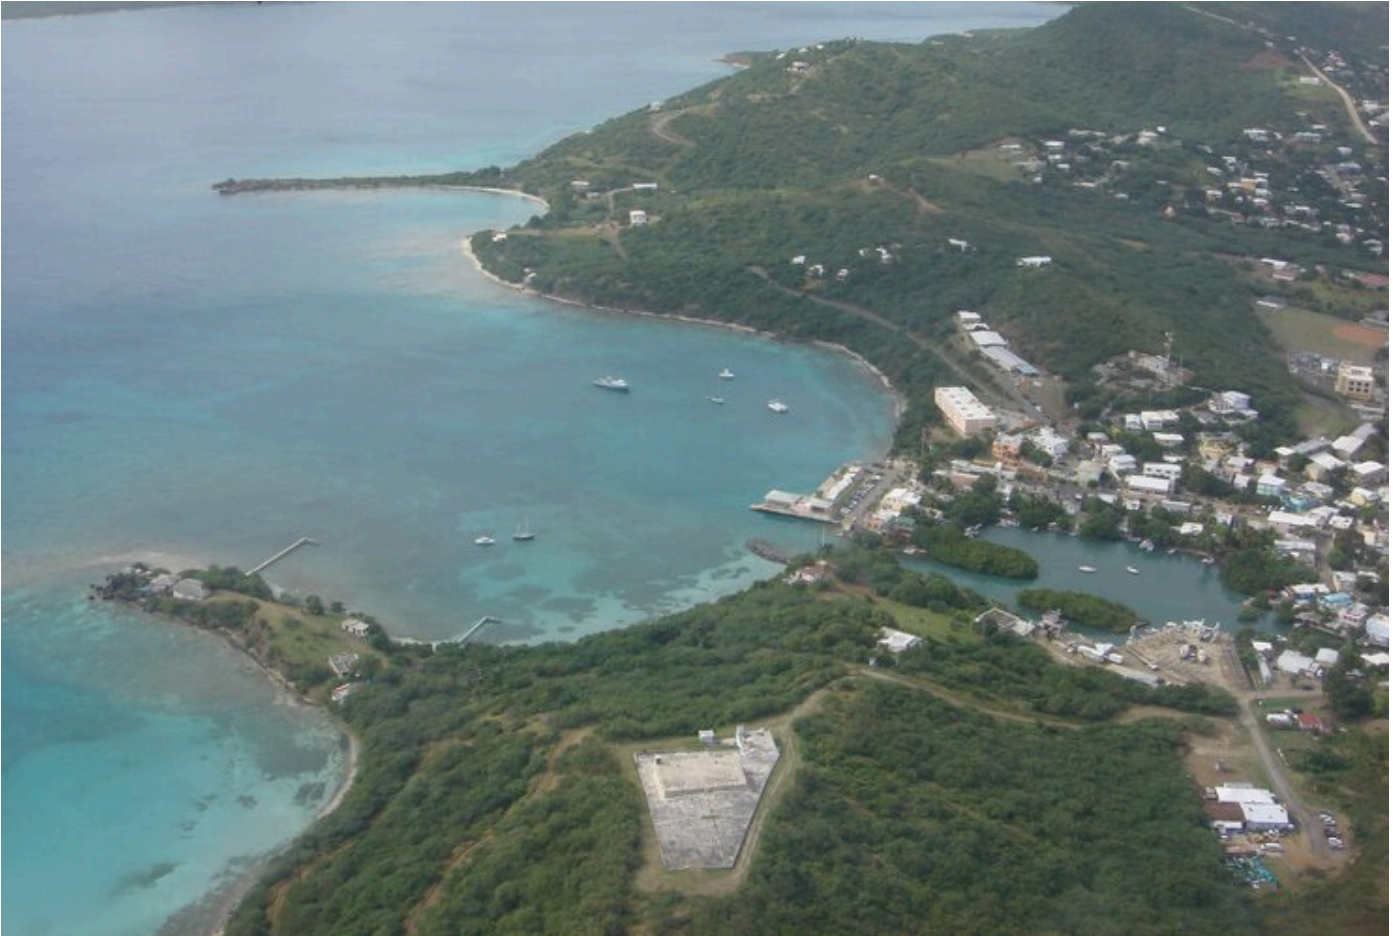
An aerial view of the Culebra coast. Tamarindo and Tamarindo Grande are toward the upper left of the photo. [Click on the image for a larger view and source information.](#)

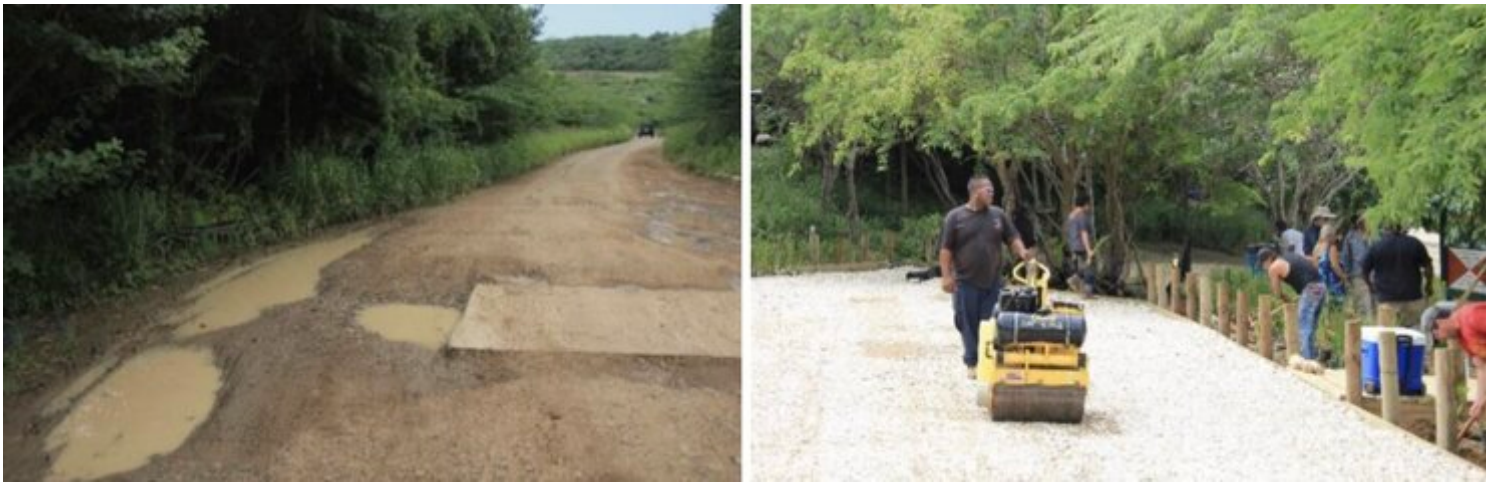
The Tamarindo Beach parking area before and after resurfacing. Click on the image for a larger view and source information.

To slow the flow of rainwater, the community leveled and stabilized the 10-12 car parking area, covered it with a layer of stone, and surrounded it with a wooden fence. To keep motor vehicles in the parking area and off the beach, fence posts were cemented in place along the edge. To further stem the flow of runoff, members of the community planted 600 grasses around the perimeter of the parking lot. They selected grass plants known for their stabilizing root systems and sediment-trapping capacity. Finally, an area near the parking lot where water accumulated after rain was broken up with swales, giving rainwater that pooled in the area a chance to infiltrate into the ground. With the parking lot secure, the team turned their attention to revegetating the area between the parking lot and the beach.

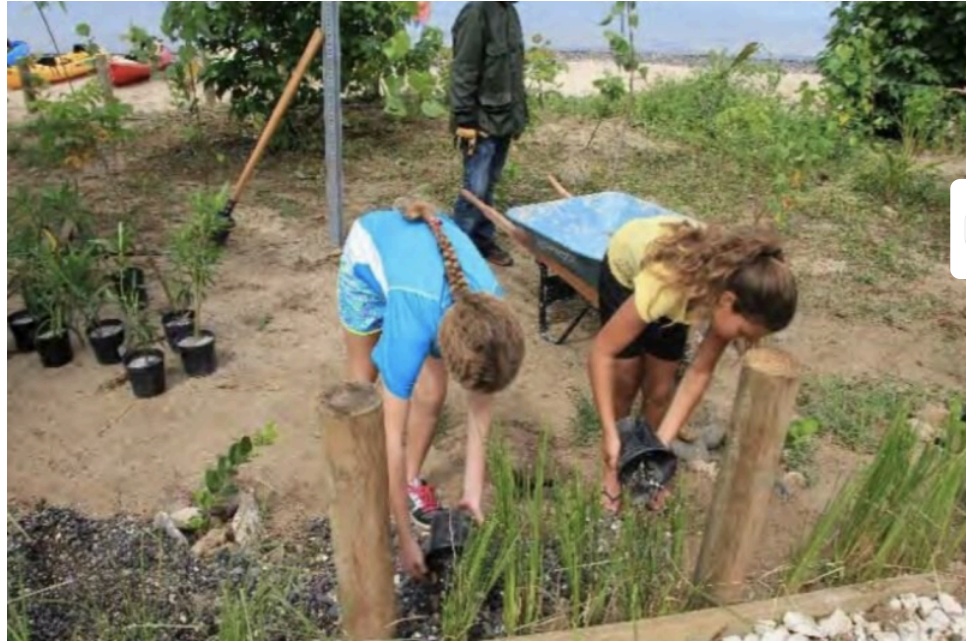
Restoring the dunes, one plant at a time. Click on the image for a larger view and source information.

Volunteers planted 325 trees and shrubs donated by the Department of Natural Resources of Puerto Rico (DNER), including sea grape, portia tree and cooperwood, and cocoplum. To guide pedestrians to the beach and away from the new plantings, three access points were clearly marked, two with small boardwalks to keep visitors off of the developing vegetation. Community members fill a 400-gallon cistern each week to ensure adequate water for the new plants.

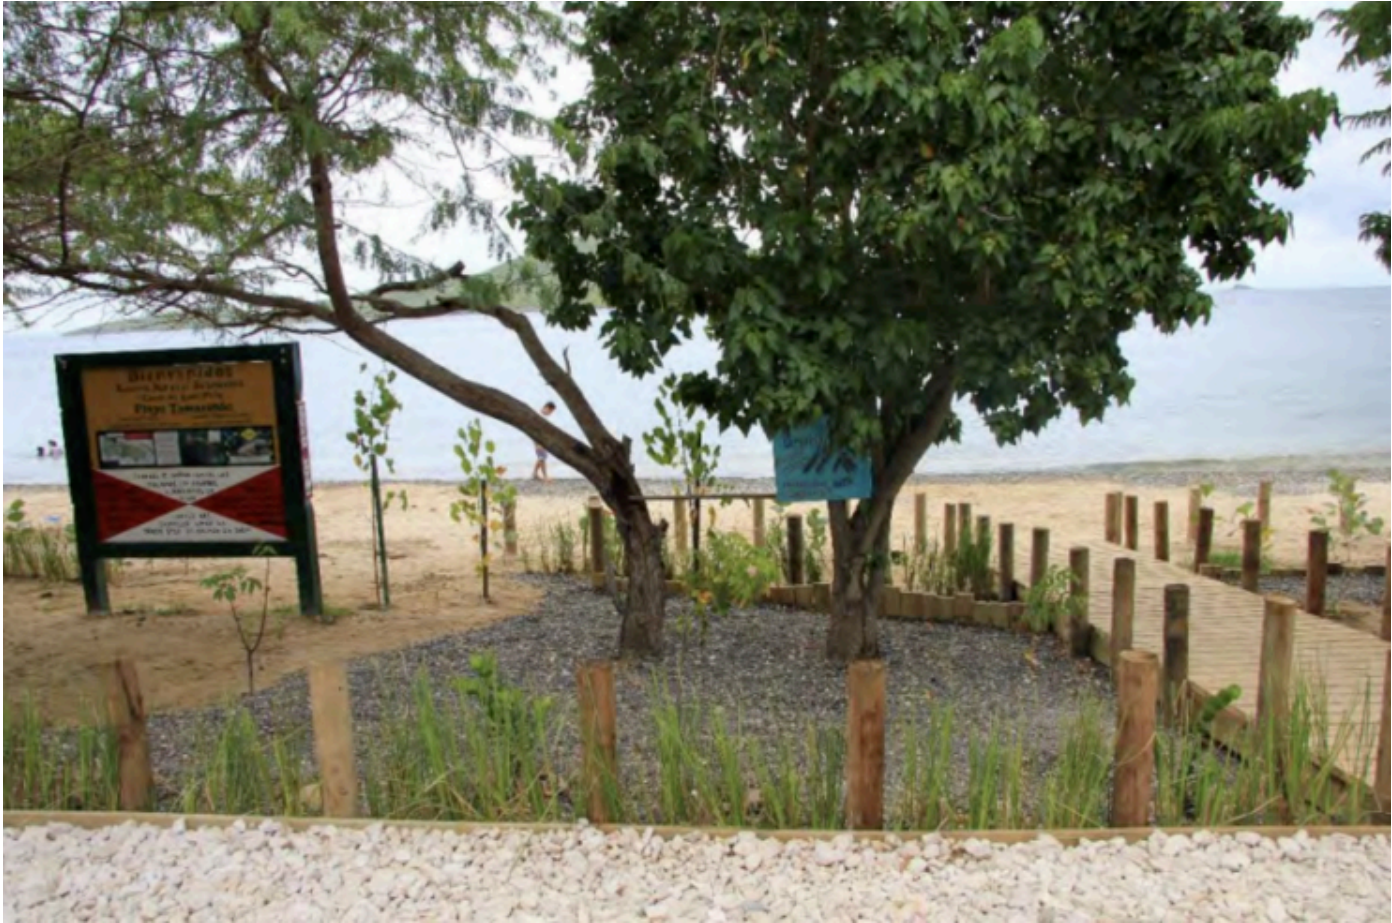
A completed boardwalk and infiltration gallery. Click on the image for a larger view and source information.

The group implemented measures to slow the flow of runoff to the beach. One tactic involved creating two small infiltration galleries to treat water coming from the parking lot. The next involved replanting areas that were denuded due to uncontrolled vehicle access to the beach.
