# Case Study by CART

Bird Track Springs Habitat Restoration on the Upper Grande Ronde River

A Case Study on Restoration August 22, 2023

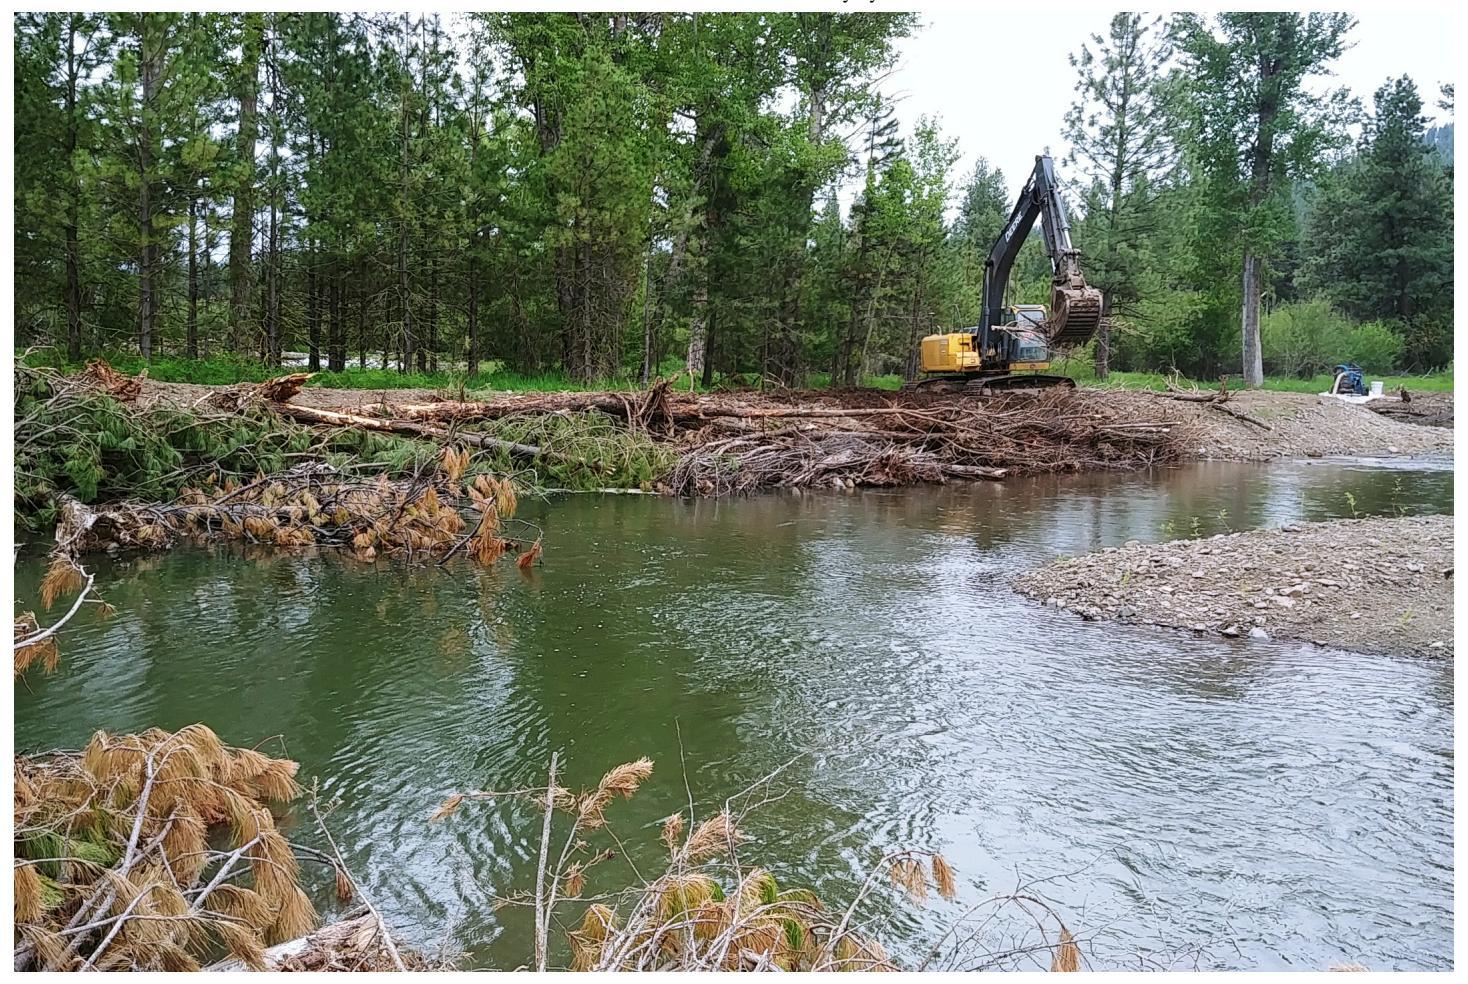
Image Caption: Lower project area showing large pool habitat and floodplain wood structures. Courtesy of Cardno.

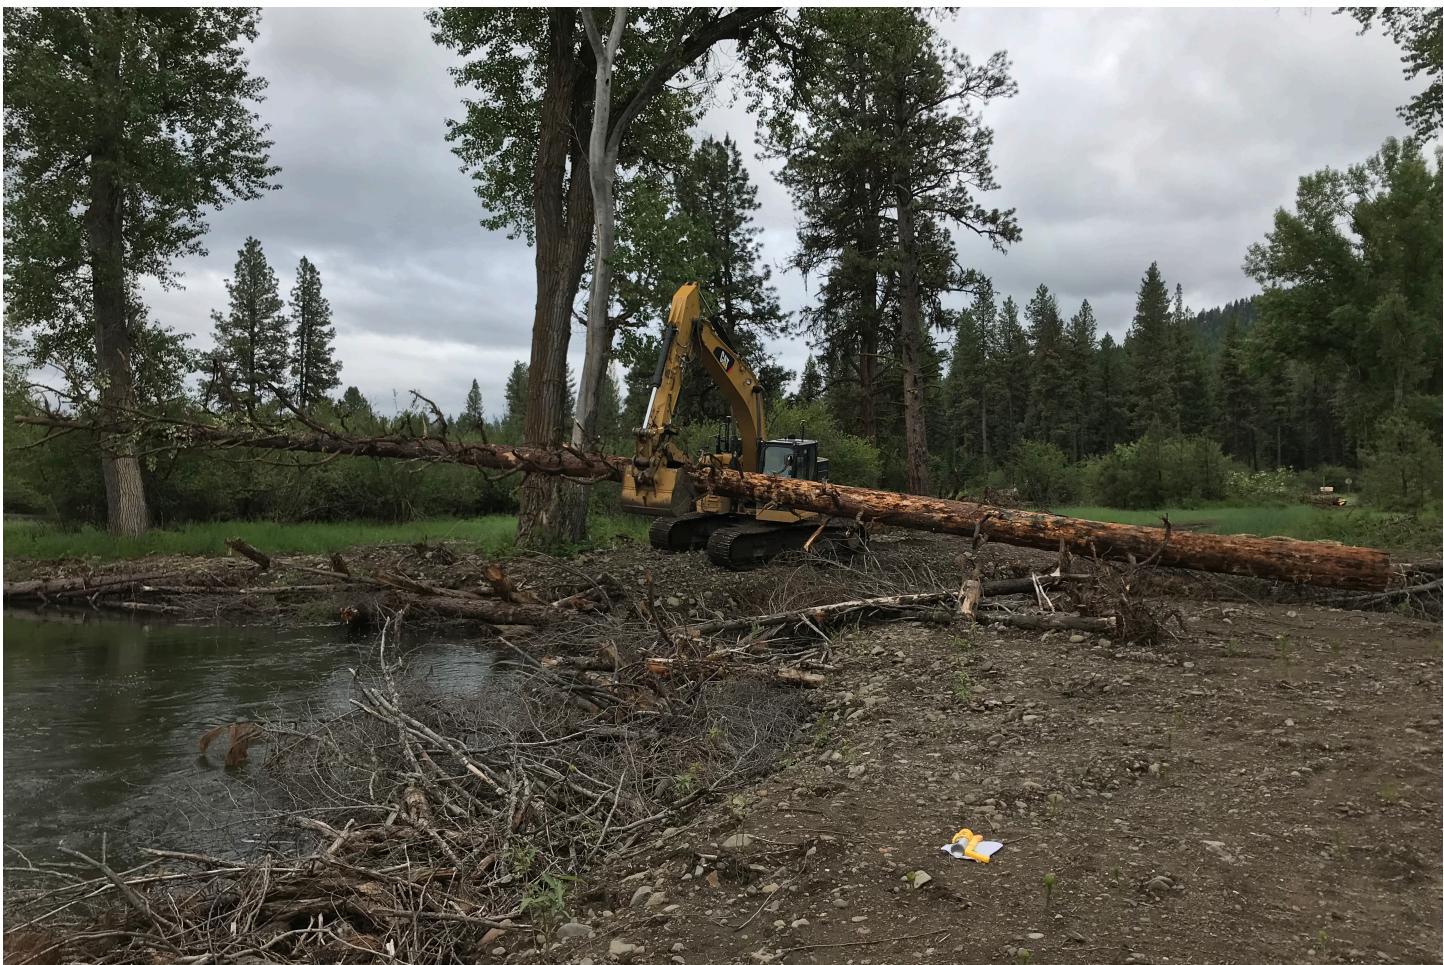
Image Caption: Bird Track Springs site midway through construction. Courtesy of Grande Ronde Model Watershed.
