Riparian Woodland and Grassland Restoration to Increase Resilience to Drought

A Case Study on Revegetation March 4, 2024 Esri, USGS | Texas Parks & Wildlife, CONANP, Esri, TomTom, Garmin, FAO, ...

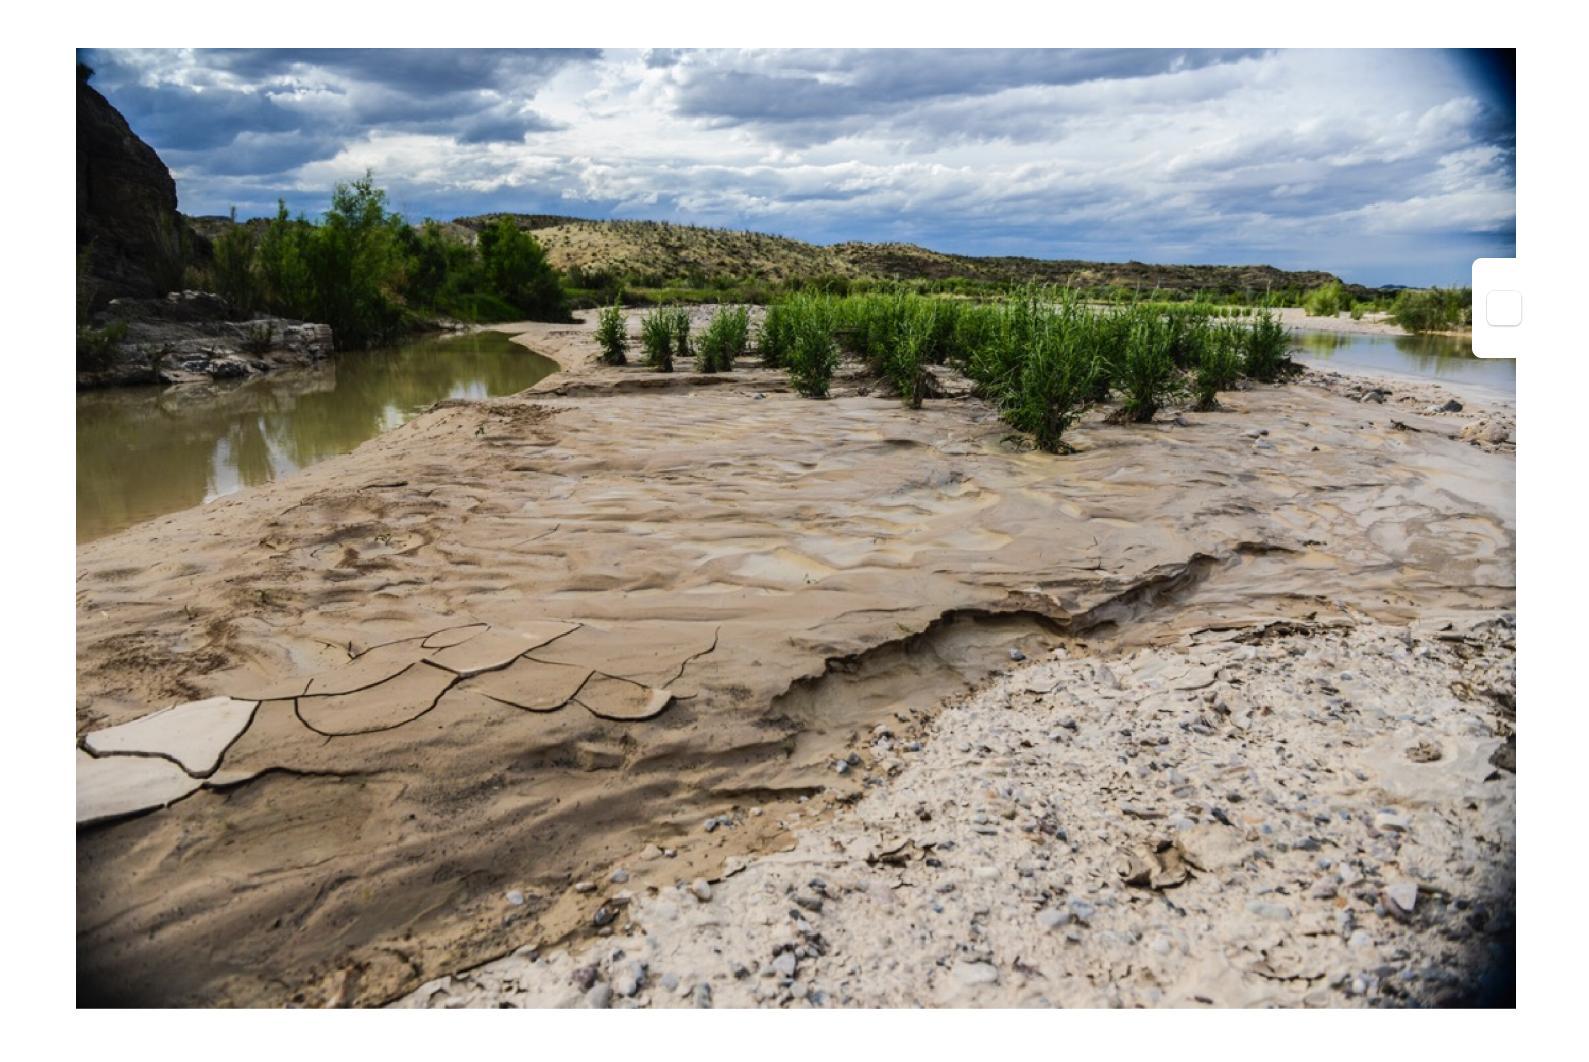
Image Caption: Fine sediment accumulation within and downstream of willow pole plantings at Terlingua Creek. Courtesy of Jeffrey Bennett, National Park Service.

Successful willow establishment improves riparian and aquatic habitat. Revegetation has led to fine sediment accumulation and channel aggradation which improves the depth and extent of the aquifer increasing the system's resiliency to drought. Revegetating degraded wetlands located on private land near the headwaters can create nursery conditions downstream and enhance natural regeneration of riparian woodlands.
