# Sears Point Wetland Restoration

from **Engineering With Nature: An Atlas, Volume 1.**

by **US Army Engineer Research and Development Center**

## San Pablo Bay, Sonoma County, California, United States

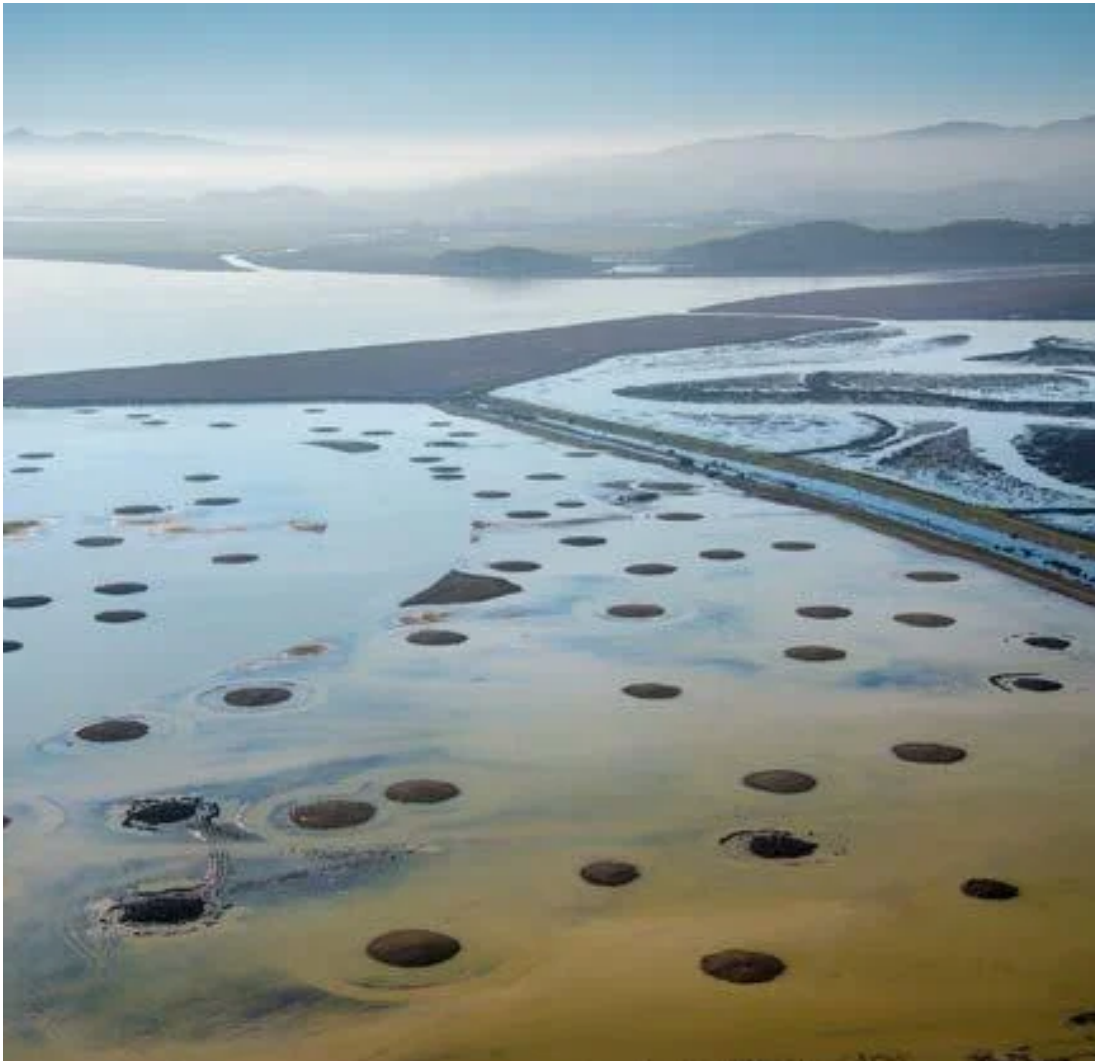
(Photo by Stephen Joseph)

Marsh mounds emerge from stormwater in early 2015.

Five hundred marsh mounds were constructed using sediment excavated in place. The mounds were distributed in various locations on the property, including in front of the levee as a protective measure. The mounds were used to slow down the flow of water so that 6 feet of sediment could accrete naturally on the site, providing optimal conditions for vegetation to take root and propagate, eventually making the marsh fully functional. By altering agricultural practices and implementing watershed management efforts, 400 acres with seasonal wetlands were also improved, along with nearly 1,000 acres of upland grasslands and riparian corridors. A sloped levee offers flood defense to nearby roads, rails, and farmland while providing upland habitat and refuge for wildlife during storm events.

The 500 mounds were designed to slow waves and water flow, so that the sediment will settle out of the water and naturally build up the marsh. Accreting the sediment through this natural process will ensure that the grain size is optimal, and that the chemistry and elevation develop exactly as the marsh requires—all necessary conditions for marsh vegetation to take root and propagate to form a fully functional marsh. The mounds may also provide refuge for wildlife in an otherwise open tidal basin and restore hydraulic functionality by promoting the creation of channels over time.

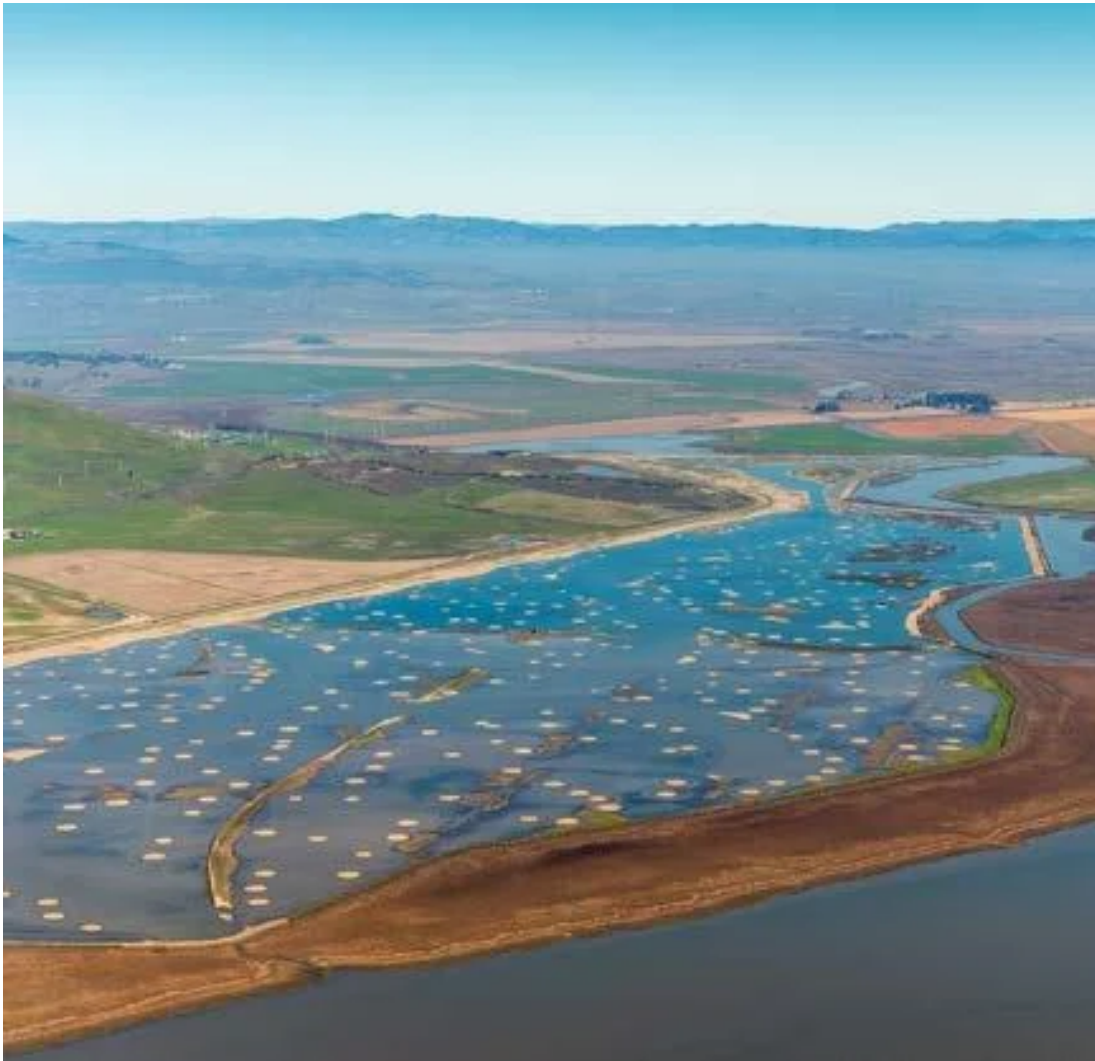
Sears Point after 2014 storms.  
(Photo by Stephen Joseph)

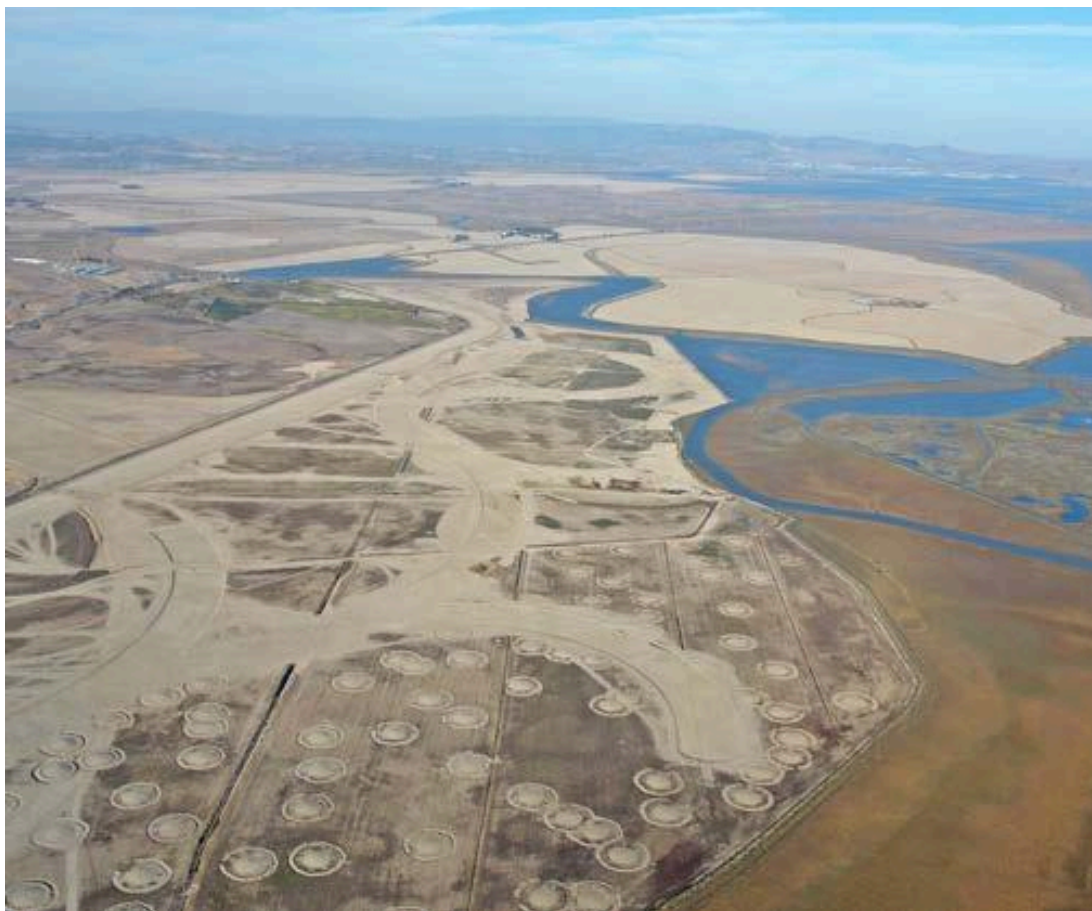
(Photo by Robert Janover)

Construction of the tidal basin.
