## Overview

The Kenilworth Marsh tidal wetland restoration project is located in Washington, District of Columbia, United States. The goal of the project was to restore areas degraded from a suite of long-term impacts including river sedimentation, contamination, and channelization. Besides the impacts of altered hydrology on the wetlands, original site substrates and vegetation were buried under dredge spoils and covered with a landfill. Work began with a review of historical changes to the site, assessment of reference conditions, and identification of key factors that restricted the recovery of the wetland. Managers then initiated a pilot study to understand optimal substrate elevations, plant species, and tidal hydrology for facilitating the restoration of the marsh. In the fall of 1992, 130,000 cubic yards of dredged material were used to fill areas in accordance with restoration design elevations. For nearly five months the newly formed marsh substrate was left fallow to allow for dewatering and settlement. At the same time, hydraulically designed tidal channels were cut into the substrate to restore tidal flow back to the system. The following spring, more than 350,000 nati

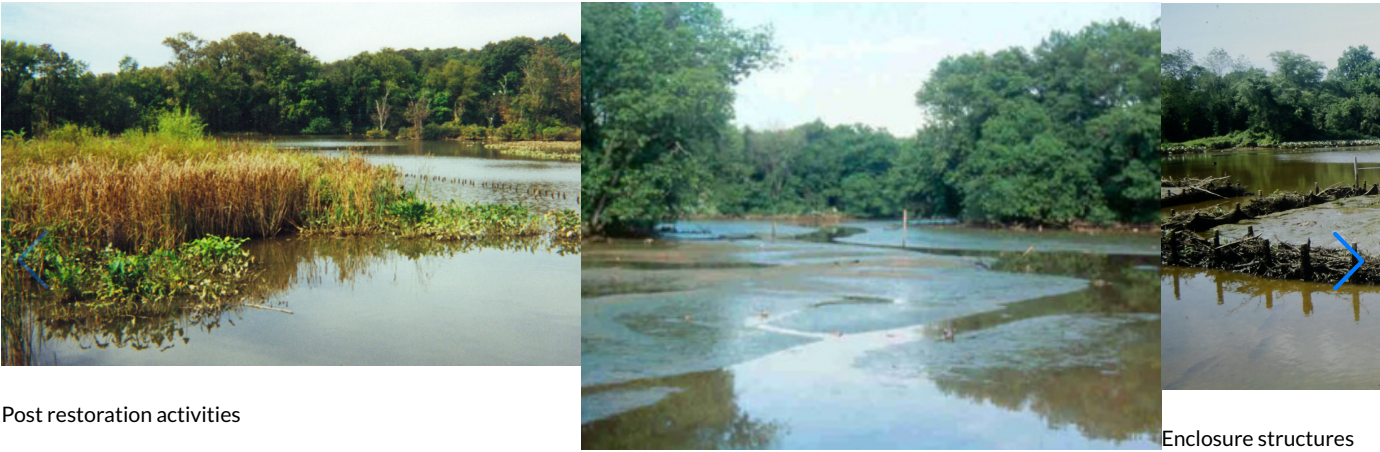
Post restoration activities

Prior to restoration

Enclosure structures
