Overview

Once completed, the Kissimmee River Restoration will be the largest river restoration project in the history of the world. All told, the project will restore over 40 square miles of river/floodplain ecosystem, including 43 miles of meandering river channel and 27,000 acres of wetlands. Jointly managed by the South Florida Water Management District (SFWMD) and the U.S. Army Corps of Engineers (USACE), the project encompasses two primary components aimed at restoring natural hydroperiods and inundation patterns to the river and its adjacent floodplain: backfilling the C-38 canal (the channelized river's main drainage) and changing water level management practices in the Kissimmee Chain of Lakes to maintain natural flow. The first phase of backfilling was completed in 2001 along approximately 12 km of C-38, and the results of post-construction monitoring surveys have been promising. While it is still too early to perform an accurate assessment of the impact on plant, fish, and herpetofaunal communities, initial observations following the restoration of flow to the channel suggest improvements in water quality (especially levels of dissolved oxygen); re-colonization by invert

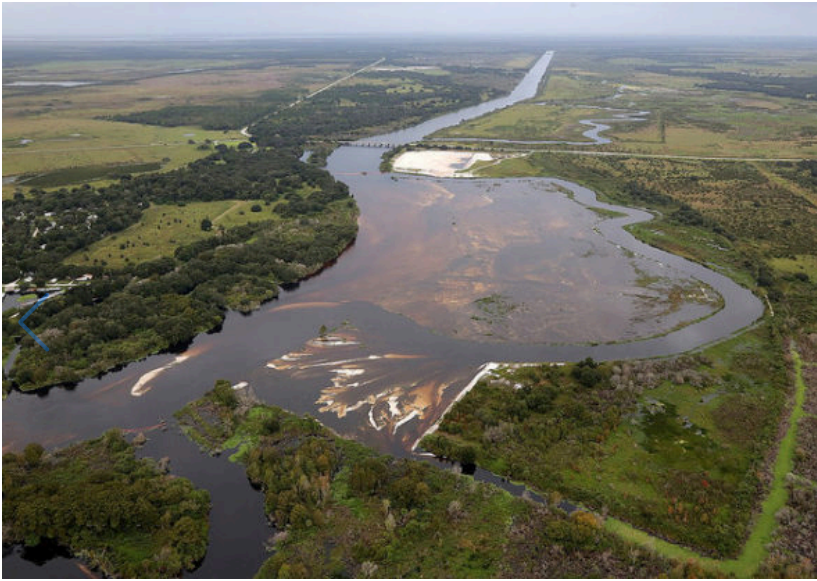
(before) Looking north at the north section of the Reach 3 backfill; Credit: SFWMD

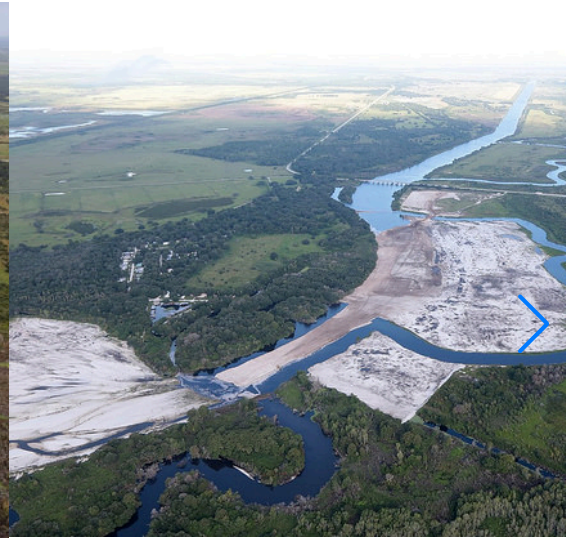
(after) Looking north at the north section of the Reach 3 C-38
SFWMD
